## STAR ONLINE PUBLICATION

**Case Number: S1625000005**

**Symptom/Vehicle Issue: (Rev. A)** Malfunction Indicator Light (MIL) Illuminated. Service Diesel Exhaust Fluid (DEF) System – See Dealer Soon Message on Electronic Vehicle Information Center (EVIC) Along With Possible Diagnostic Trouble Code (DTC) P241D - SCR Inducement - Forced Engine Shutdown.

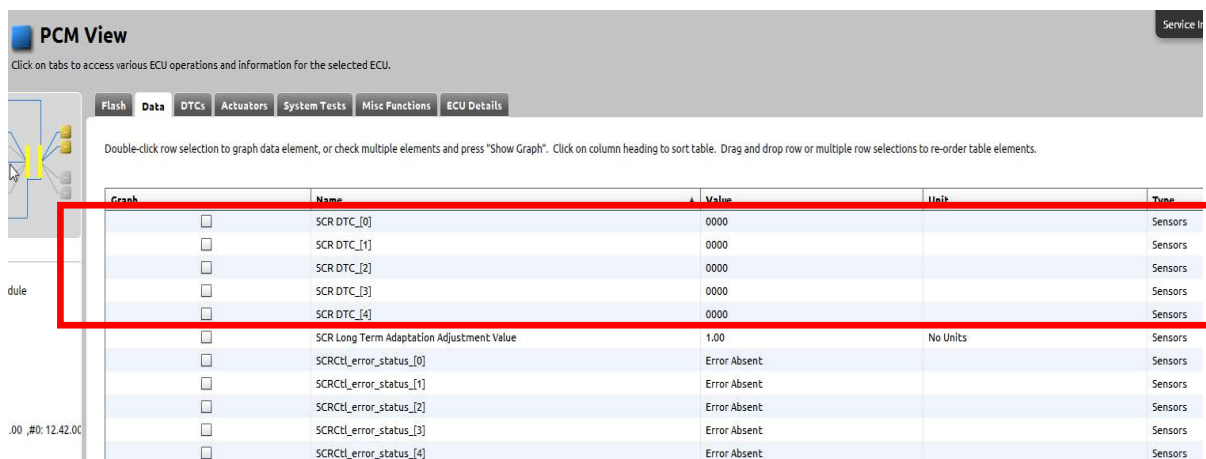
**Figure 1**

In addition, you can run into situations where the codes are cleared prior to arrival. This will present a situation where there are no codes visible but the message remains. Should this happen, the original DTC that set the message will be stored in the ECM data list under SCR DTC. See (**Figure 1**) on the next page.
