## Technical product information

| <b>Topic</b> | Bentayga V8 Kovomo - DTC P310B00 with Symptom Code 2638 - Check Engine Lamp - Fuel Pressure Regulation |
| <b>Transaction No.</b> | 2058484/9 |

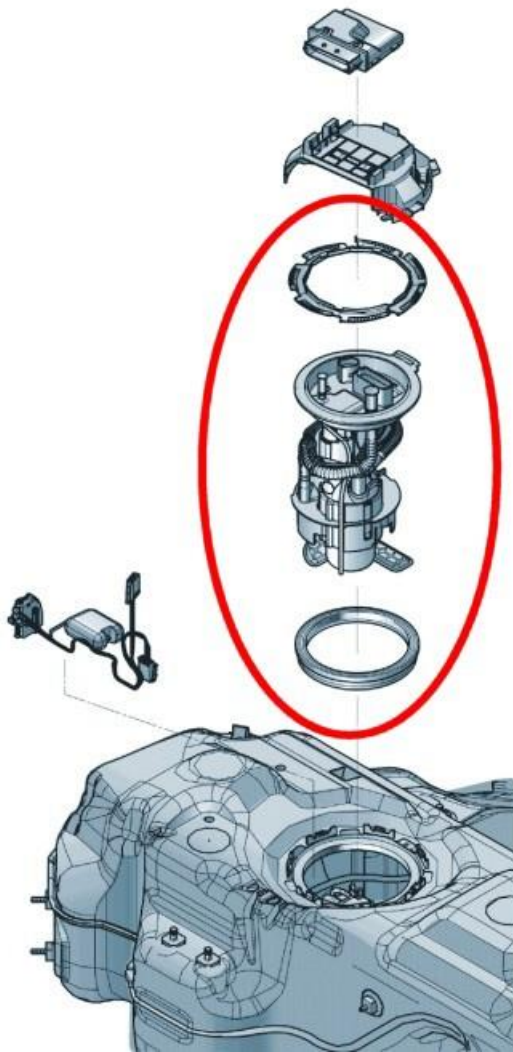
Figure 5

11) In the event the value is between minus 100 to 200 kPa - the Fuel Delivery Module within the fuel tank (Figure 5) should be replaced - Refer to Repair Group 20 Fuel supply, gas operation / 4.0L V8 TSI / Fuel pump, fuel level sensors, and jet pump (RH) - To remove and fit.

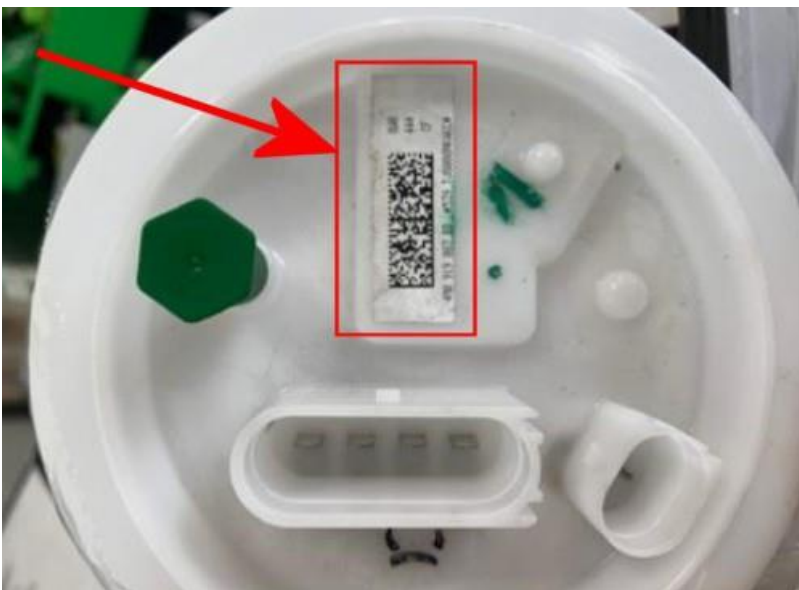
■  
**IMPORTANT:** Once the fuel delivery module has been replaced, the operative should attach a clear of the manufacture information as per the example shown in Figure 6
