# Technical product information

| Topic | DTC P1B8100 stored within 006B – Aerodynamic control unit - No test plan in ODIS to assist with diagnosis |
| Brand | Bentley |
| Transaction No. | 2068151/1 |

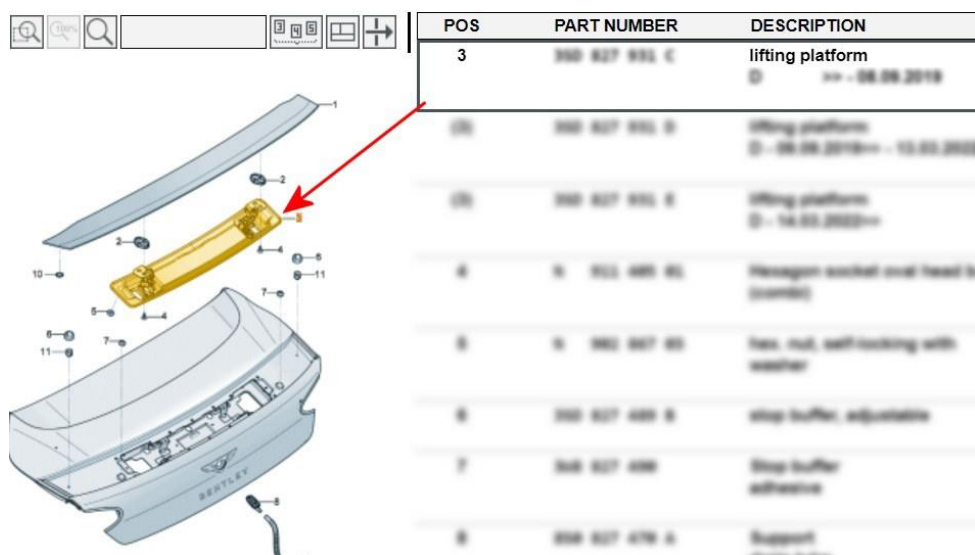
Figure 1

Refer to the ETKA parts catalogue for the deployable rear spoiler assembly (lifting platform as Figure 1) part number
