# TECHNICAL BULLETIN

LTB00304NAS7

### Fuel Gauge Operation / DTC U0128-00 Stored

LR4 (L319)

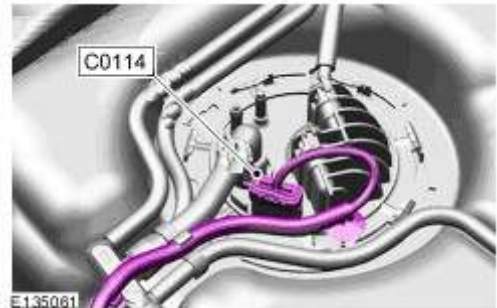
14. The first area to check before commencing any further work is the vehicle harness to fuel tank connection. A poor connection may exist where the harness plugs into the flange (see E135061). To test, with the ignition turned off and connector in place, pull the connector upwards to give a worst case scenario connection situation. Turn on the ignition, does the gauge drop to zero, repeat several times. If fault is found, remove connector and ensure pin connections are not loose and that they are correctly retained in the connector housing. If no fault can be found confirm the connector is fitted and pushed fully home and continue with further diagnostics as detailed TOPlx section 310-01.

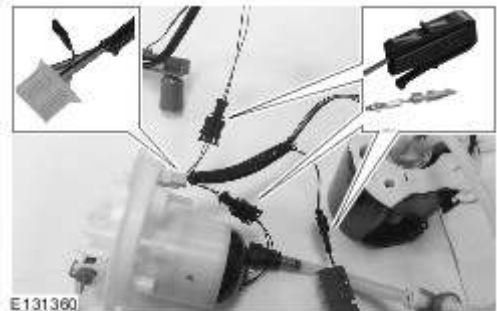
15. Refer to Workshop Manual section 310-01 and perform the appropriate diagnostic and repair procedure(s).  
△ **NOTE: Not all derivatives will have the same number of connectors. Fuel tank module / sender components removed from fuel tank for clarity.**

- Backed out pin / wire could be any of the wires on the connector assembly(s); all must be checked.
  16. If a failure to the harness or individual fuel sender cannot be verified at any point during the diagnostic stage, then both fuel level senders and the flange should be replaced to avoid the possibility of a repeat repair.
