# TECHNICAL BULLETIN

## LTB00304NAS8

### **SECTION: 310-00**

Fuel Gauge Operation / DTC U0128-00 Stored

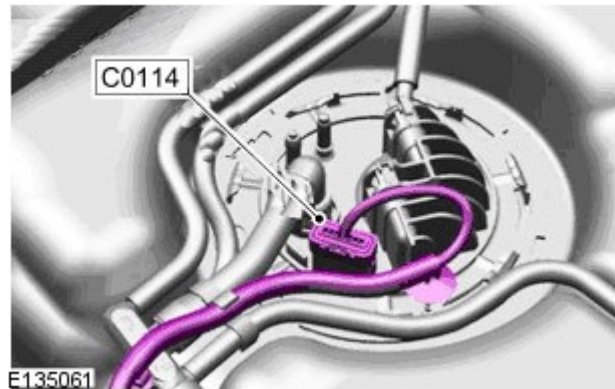
- 13.** The first area to check before commencing any further work is the vehicle harness to fuel tank connection. A poor connection may exist where the harness plugs into the flange.

1. To test, with the ignition turned 'OFF' and connector in place, pull the connector upwards to give a worse case scenario connection situation.

2. Turn the ignition 'ON'.

- does the gauge drop to zero?

3. Repeat several times.

- If fault is found, remove connector and ensure pin connections are not loose and that they are correctly retained in the connector housing.

- If no fault can be found, confirm the connector is fitted and pushed fully home and continue with further diagnostics as detailed TOPIx Workshop Manual section 310-01C / D: Fuel Tank and Lines Diagnosis and Testing.
