# Technical Service Bulletin

19 Red coolant warning lamp on, DTCs P218100, P017B00, P017C00, and/or P017E00 are stored in the ECM

19 22 32 2062951/2 October 21, 2022. Supersedes Technical Service Bulletin Group 19 number 21-16 dated May 3, 2021, for reasons listed below.

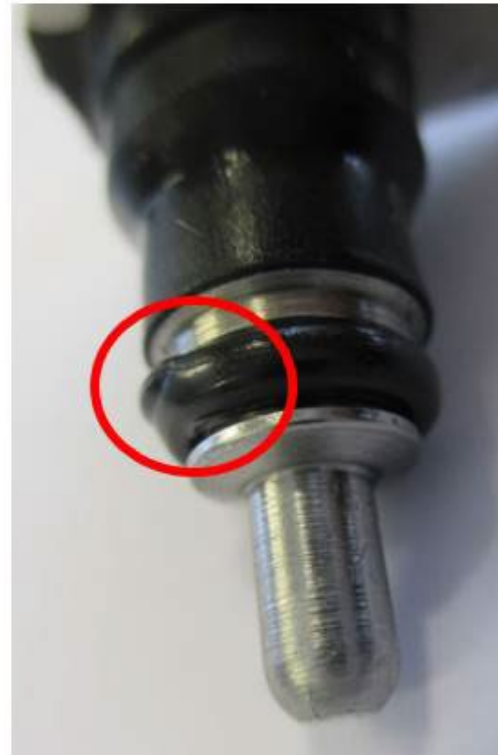
Damage to the O-ring of the temperature sensor can cause water intrusion inside the plastic housing of the coolant temperature sender G407 (cylinder head temperature sensor). The moisture can damage the sensor element. The loss of function can be sporadic.

2. It is very important to also check whether the O-ring located directly on the tip of the coolant temperature sender G407 is visibly damaged and/or pinched (Figure 1).

*Figure 1. O-ring is pinched.*

3. Replace the G407 if it is damaged and/or pinched.
