# Technical Service Bulletin

## 13 Starter/generator drive belt is noisy or came off, DTC P2BA300 may be stored in the ECM

20 22 50 2061461/5 October 27, 2022. Supersedes Technical Service Bulletin Group 13 number 21-15 dated July 14, 2021, for reasons listed below.

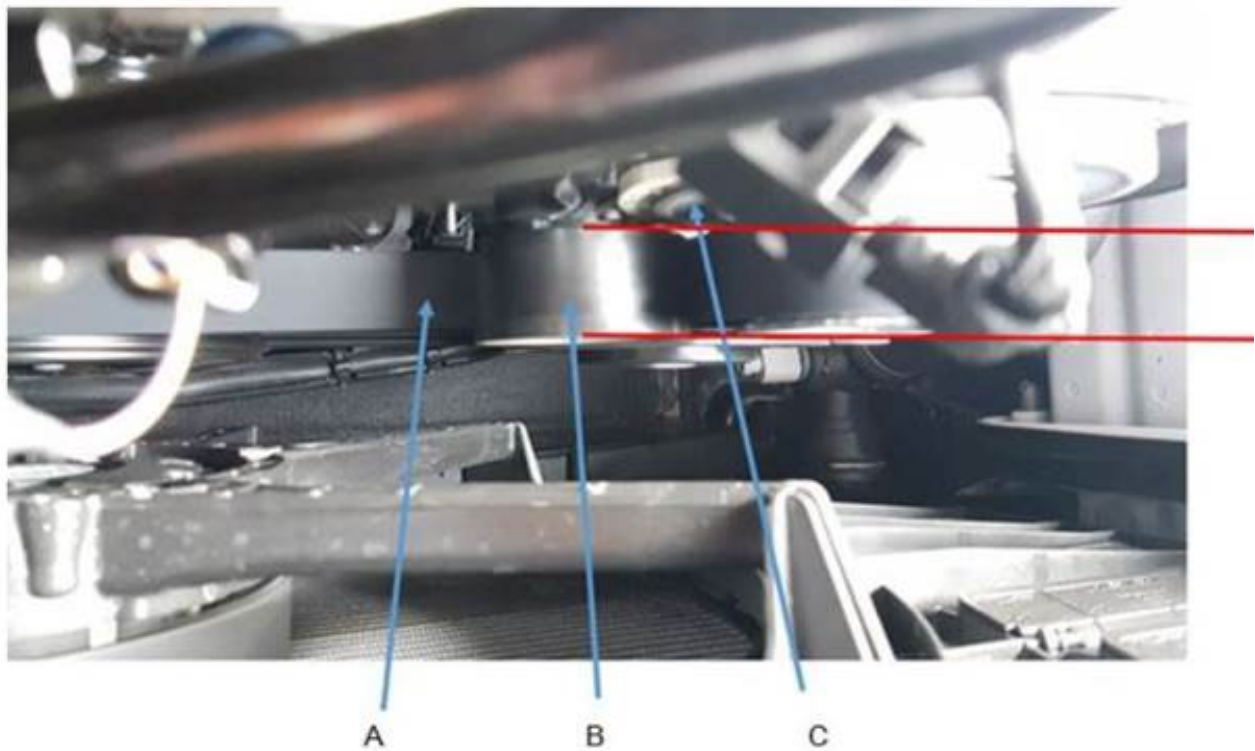
1. Run the engine at idle speed.
2. The belt must not protrude forward or backward over the roller edge of the tensioner (Figure 2, red marks).

*Figure 2. Check to ensure that the poly V-belt is not protruding in either direction.*

Explanation of Figure 2 (view from above into the engine compartment):

A = poly V-belt.

B = tensioning roller of the belt tensioner.

Check for correct belt running alignment after poly V-belt and tensioner replacement as follows:
