# Technical Service Bulletin

CHECK ENGINE LIGHT ON WITH DTC P0126:00

Bulletin No.: 01-013/22

Last Issued : 10/19/2022

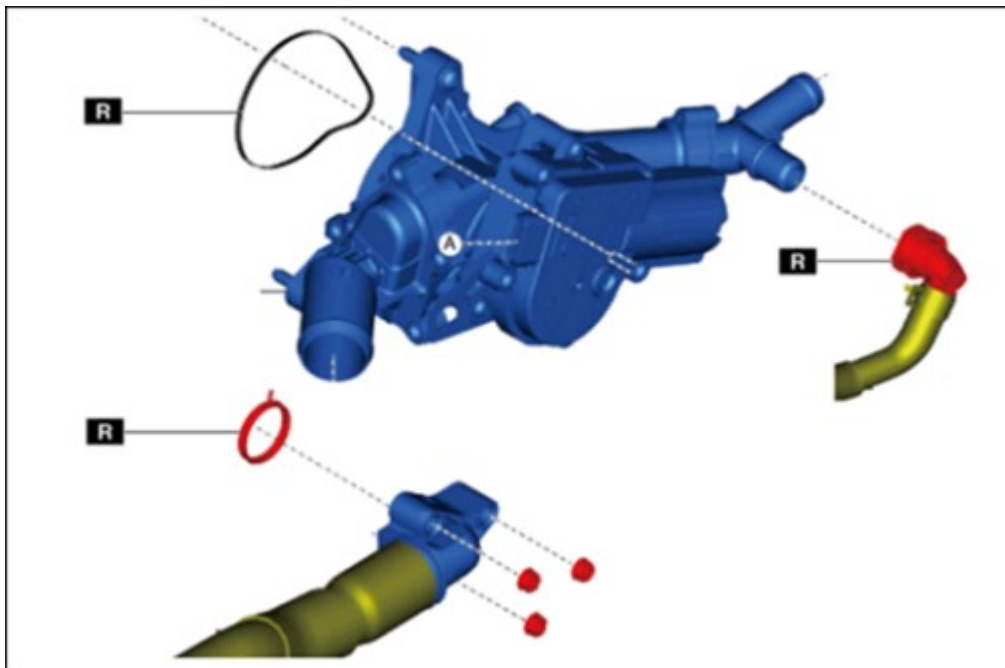
**Replacement Part Locations**

- O-ring
- Gasket
- Connector

2. Replace the coolant control valve with a new one according to the instruction on MGSS (COOLANT CONTROL VALVE REMOVAL/INSTALLATION).

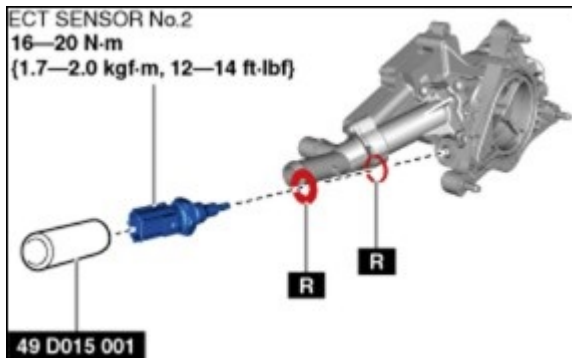
- O-ring and washer for ECT sensor No.2

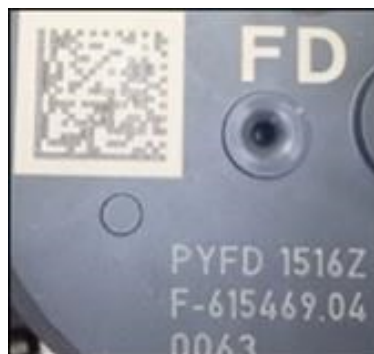
1. With a smart phone, scan the two dimensional code on the water control valve.
2. The code consists of three blocks of codes where the sample picture is read as PYFD1516Z 171115 0000063 and the second block of the code is the production date in YYMMDD format.

- If the second block of the code is 201116 or greater (meaning November 16, 2020 or later), the coolant control valve is modified.

**NOTE:** Since the modification has been implemented during the production of the part number without a suffix, it is necessary to check the suffix and the production date code of the obtained part.

- If available part is PYFD-15-16ZA or with later suffix, the following procedure is not necessary.
