## STAR ONLINE PUBLICATION

**Case Number:** S228A000003 – REV. A

**Symptom/Vehicle Issue:** Uconnect Box Error Message On Radio Screen And Diagnostic Trouble Code (DTC) code B22A9-96 Set

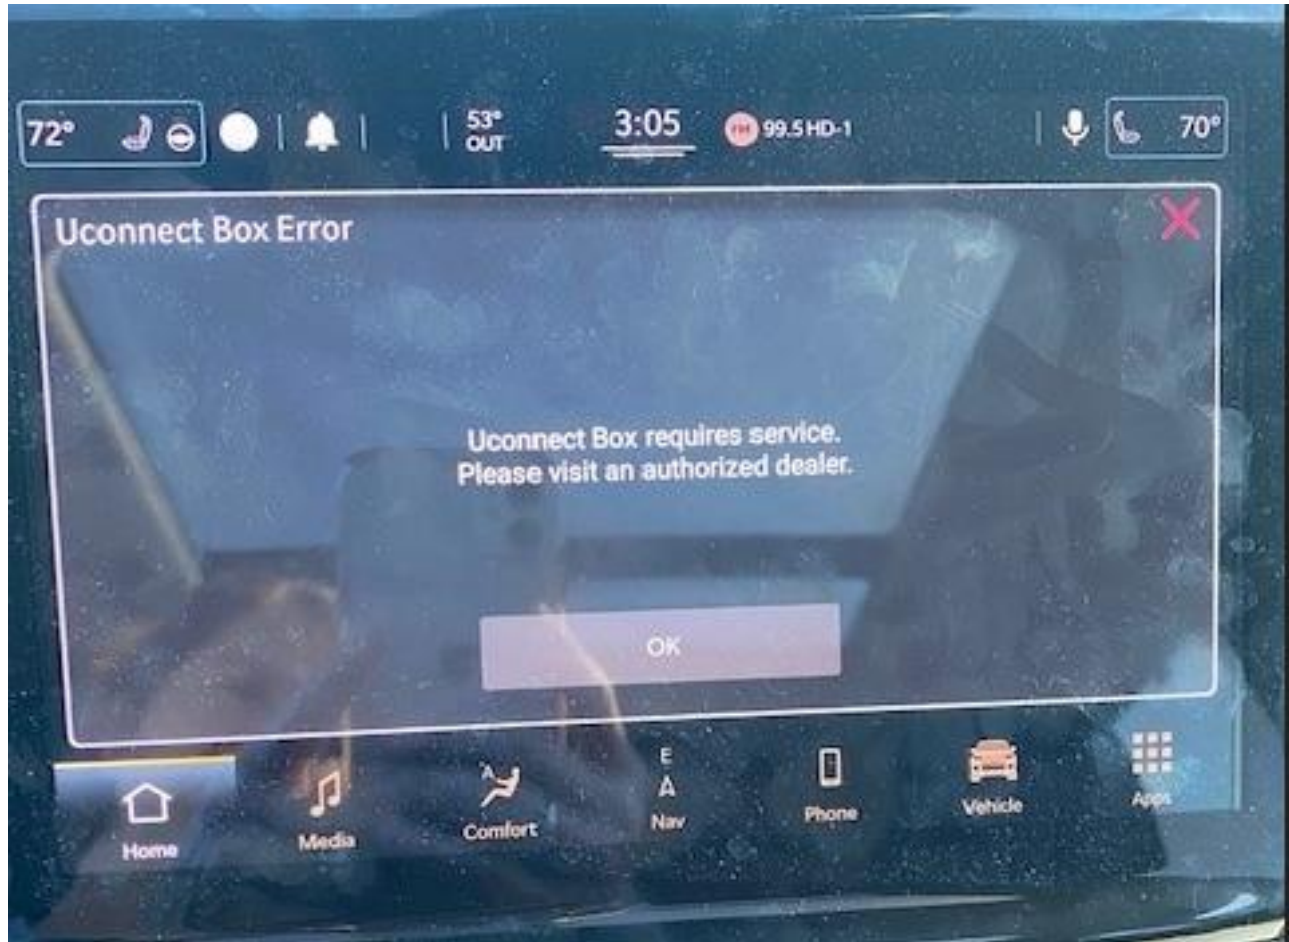
**Discussion:** The customer may report “Uconnect Box requires service” error popup on radio screen every time the vehicle starts. wiTECH shows active DTC B22A9-96 (ECU internal performance) set by Telematics Box Module 2, (TBM2).

Fig 1 Error Message

1. Check the TBM2 software version and update the TBM2 if service software is available.
2. Verify if Uconnect box error message disappeared and DTC went stored.

3. If the issue continues, pull out the TBM2 module fuse.
4. Disconnect all TBM2 harness connectors.
5. Disconnect all related in-line harness connections (if equipped).

6. Disconnect the related component harness connectors.
7. Inspect harness connectors, component connectors, and all male and female terminals for connector improper installation, connector lock damage, corrosion, water intrusion, bent terminals, overheating or terminal discolored, terminals pushed out.  
Perform a terminal drag test on each connector terminal to verify proper terminal tension.

8. Repair any conditions that are found.
9. Reconnect all TBM2 harness connectors and in-line harness connectors and related component harness connectors. Be certain that all harness connectors are fully seated, and the connector locks are fully engaged.

10. Plug in the TBM fuse.
11. Perform Proxi and TBM2 hard reset.
12. Erase the DTCs and perform wiTech scan again.
13. Replace the TBM2 module, if B22A9-96 DTC is still active.
