# TECHNICAL SERVICE BULLETIN

| AT22-014 | NTB22-093 | October 27, 2022 |

## DTC P0780 STORED IN THE TCM

**APPLIED VEHICLES:** 2021 Rogue (T33)  
**APPLIED ENGINES:** PR25DD

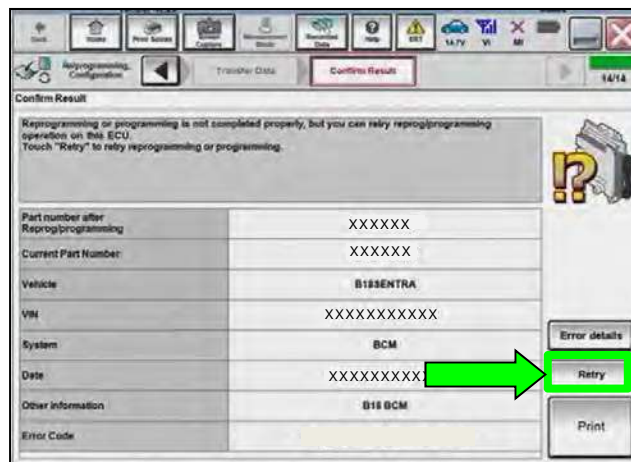
Figure 16

If reprogramming does not complete and the “!?” symbol displays as shown in Figure 16:

- Check battery voltage (12.0 – 15.5V).
- Ignition is ON, Engine is OFF.
- External Bluetooth® devices are OFF.
- All electrical loads are OFF.
- Select **Retry** and follow the on screen instructions.

**HINT:** **Retry** may not go through on first attempt and can be selected more than once.

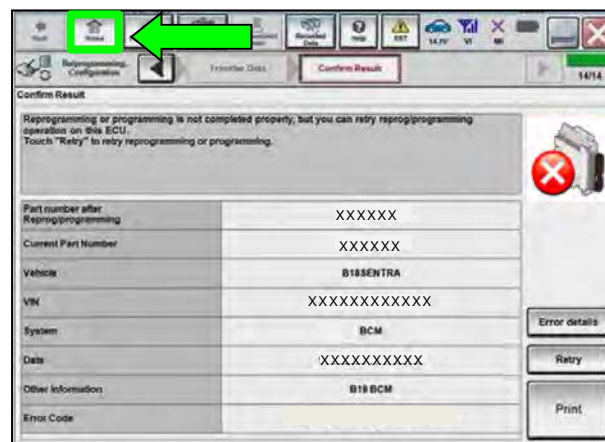
Figure 17

If reprogramming does not complete and the “X” symbol displays as shown in Figure 17:

- **Do not disconnect the VI or shut down C-III plus if reprogramming does not complete.**
- Check battery voltage (12.0 – 15.5V).
- CONSULT A/C adapter is plugged in.
- Ignition is ON, Engine is OFF.
- Transmission in Park.
- All C-III plus / VI cables are securely connected.
- All C-III plus updates are installed.
- Select **Home**, and then restart the reprogram procedure from the beginning.
