# TECHNICAL SERVICE BULLETIN

| EL22-013 | NTB22-094 | October 26, 2022 |

## DTC P161D STORED IN BCM

**APPLIED VEHICLES:** 2020-2021 Sentra (B18)

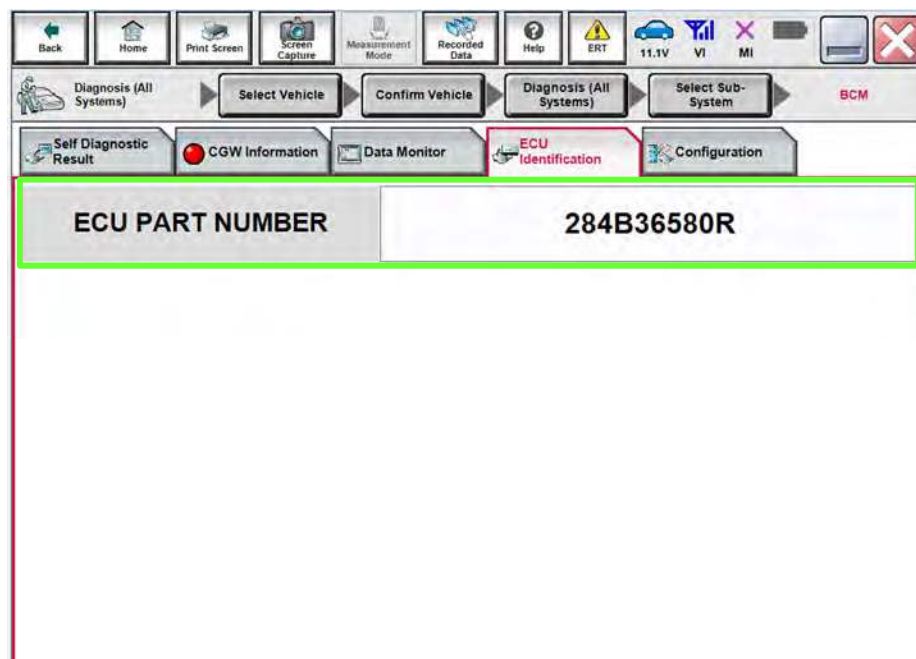
Figure 8

15. Confirm that **ECU PART NUMBER** is "284B33613R" (20MY) or "284B36580R" (21MY).
  - If **ECU PART NUMBER** is "284B33370R", this bulletin does not apply.

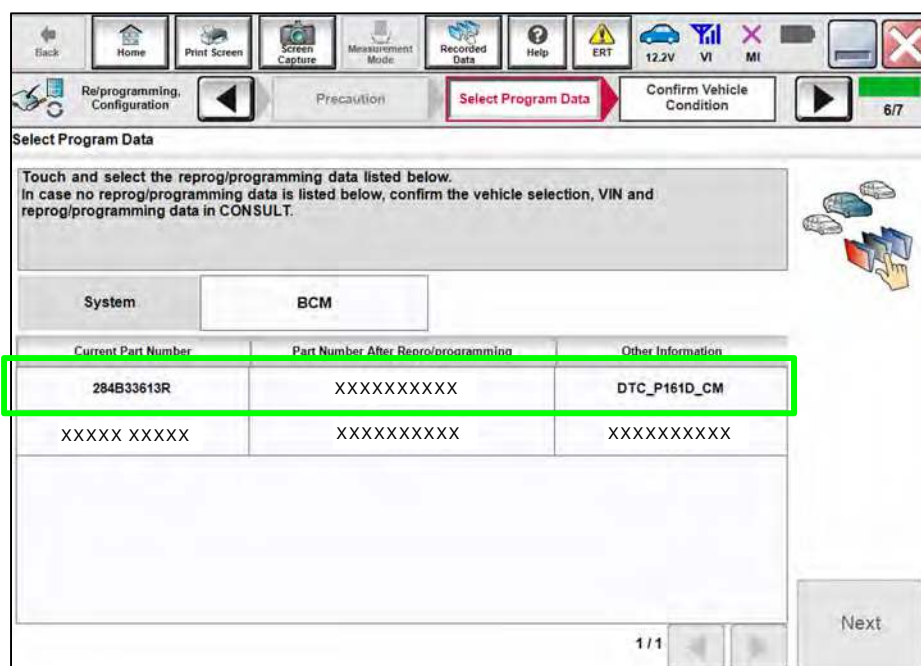
Figure 23

31. Confirm that a reprogram is available.

- If "DTC\_P161D\_CM" under **Other Information** is listed, select it and then select **Next**.
- If "DTC\_P161D\_CM" is not listed, this bulletin does not apply. Skip to step 58 on page 28.

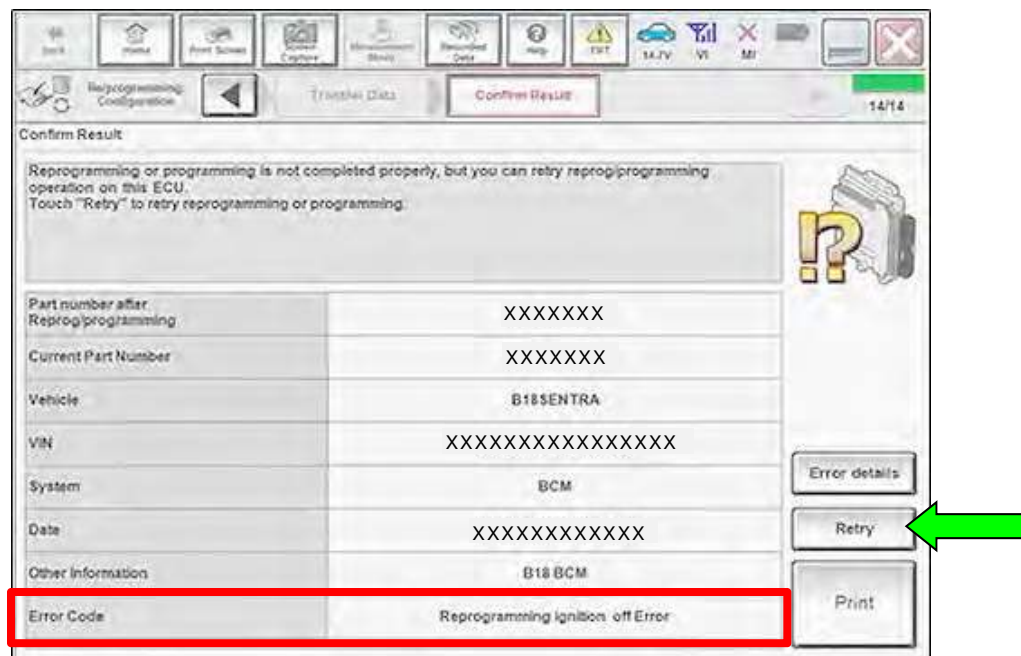
Figure 28

36. Toward the end of the reprogram, the CONSULT will show **Error Code** "Reprogramming Ignition off Error" and the vehicle ignition will turn OFF.
  - a. Turn the ignition ON, engine OFF.
  - b. Select **Retry**.

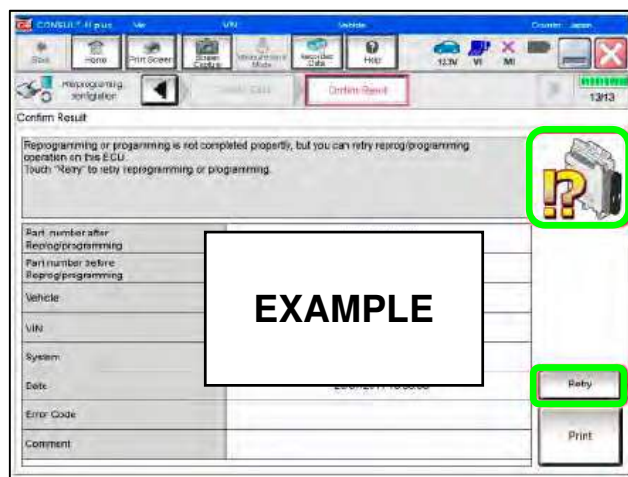
Figure 31

**If reprogramming does not complete and the “!” icon displays, as shown in Figure 31:**

- Check battery voltage (12.0 - 15.5 V).
- Ignition is ON, engine OFF. Or if EV in Ready Mode.
- External Bluetooth® devices are OFF.
- **All** electrical loads are OFF.
- Select **Retry** and follow the on screen instructions.
- **Retry** may not go through on first attempt and can be selected more than once.

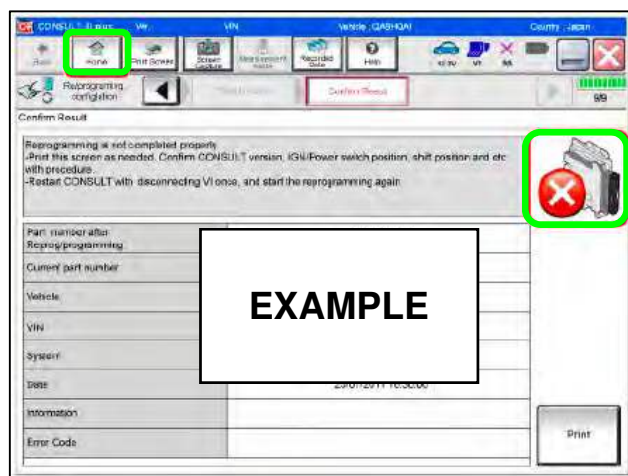
Figure 32

**If reprogramming does not complete and the “X” icon displays, as shown in Figure 32:**

- Check battery voltage (12.0 - 15.5 V).
- CONSULT A/C adapter is plugged in.
- Ignition is ON, engine OFF. Or if EV in Ready Mode.
- Transmission is in Park.
- All CONSULT VI cables are securely connected.
- All C-III plus updates are installed.
- Select **Home**, and restart the reprogram procedure from the beginning.
