# Service Bulletin

Bulletin No.: 22-NA-224

**Subject:** Reduced Engine Power, Malfunction Indicator Lamp (MIL) Illuminated - DTC's P0101, P0172, P0299, P0506 and/or P1101 Set

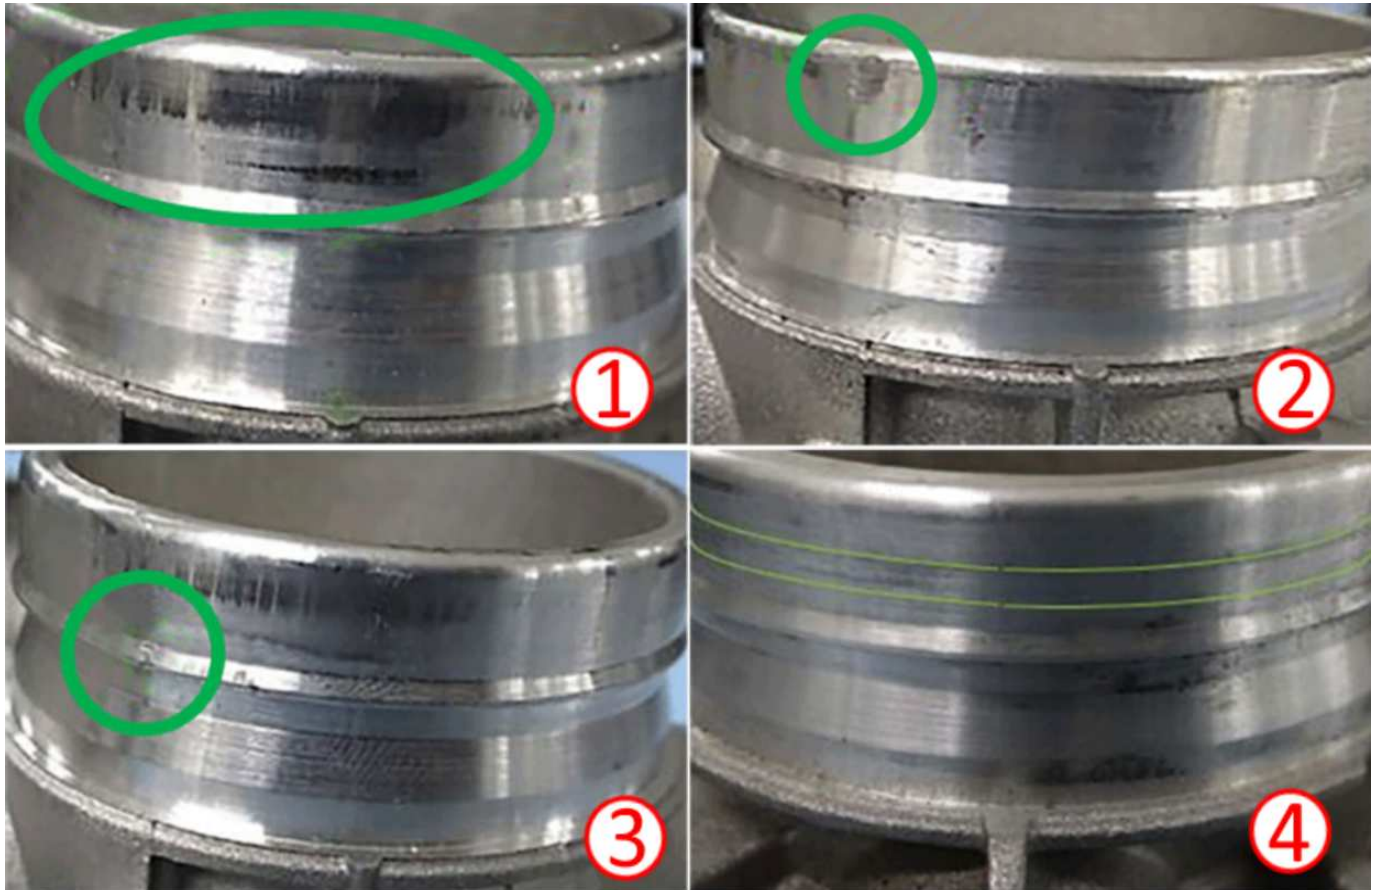
5400480

Graphics 1–4 show normal witness marks on the throttle body and normally will not require replacement.

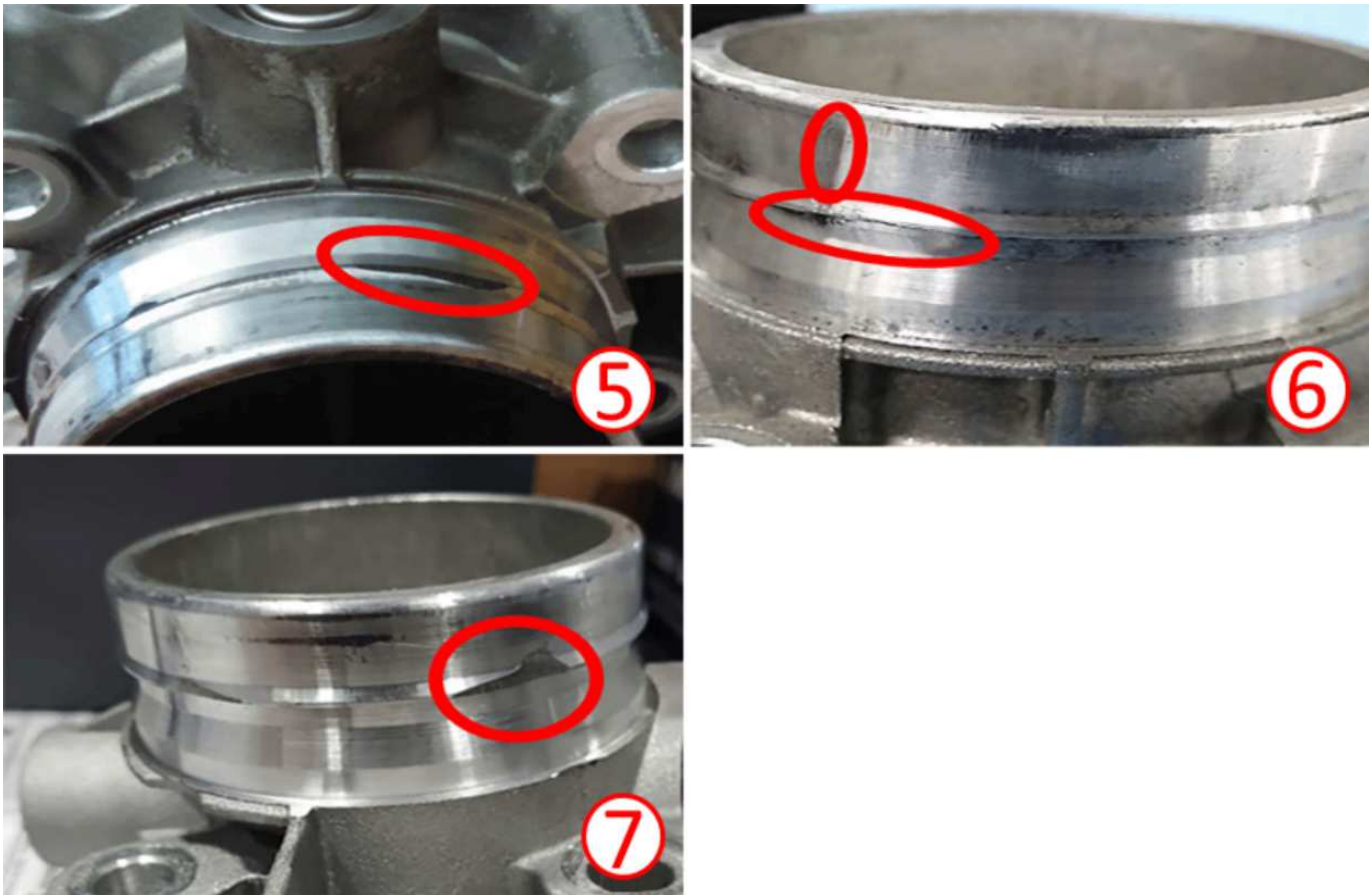
Graphics 5-7 show abnormal witness marks or damage to throttle body and replacement would be required.

If the tube is found to be damaged or the O-ring seal is missing, replace the tube assembly.
