# Technical Service Bulletin

## 34 Function restriction with event memory entry P071800 - P276800 (symptom 20736 - 20737)

34 22 60 2067653/2 November 2, 2022. Supersedes Technical Service Bulletin Group 34 number 22-59 dated July 29, 2022, for reasons listed below.

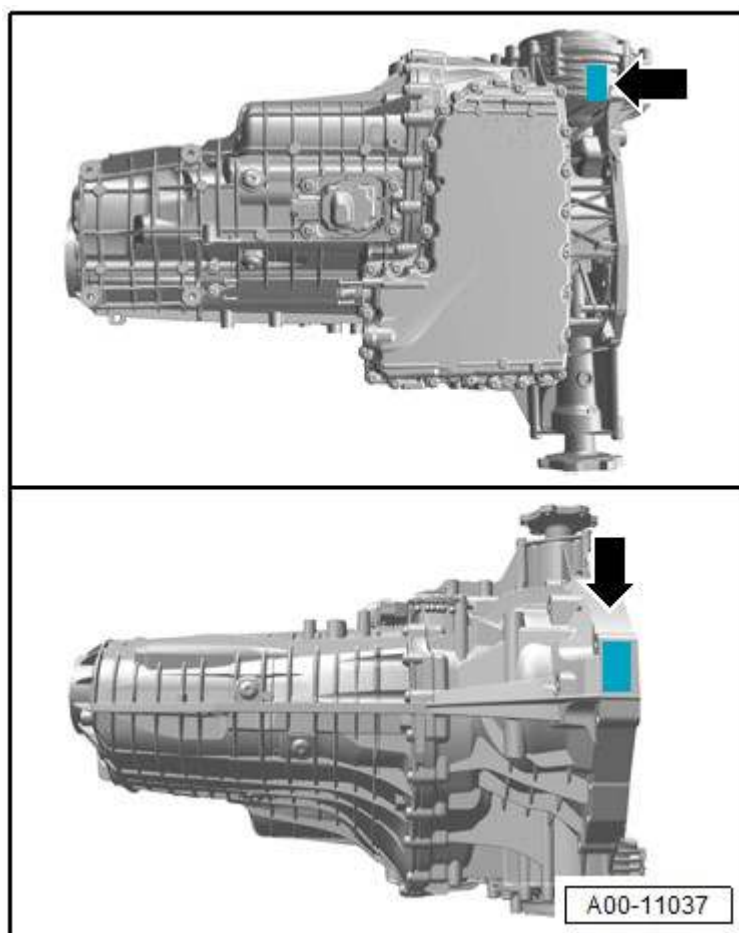
- **First determine if the Transmission was built within the date range of June 15, 2020, and May 31, 2022.**
- Check one of the transmission data stamps which are located on the bottom of the front differential and the top of the bell housing (Figure1).

*Figure 1. Locations of data stampings.*
