42 Booming noise from rear area while vehicle is moving (depending on vehicle speed/wheel speed) DTC P18F100

42 22 50 2068250/1 November 4, 2022.

| Model(s) | Year | VIN Range | Vehicle-Specific Equipment |
|---|---|---|---|
| Q4 e-tron, and<br>Q4 e-tron<br>quattro | 2022 – 2023 | All | Not Applicable |

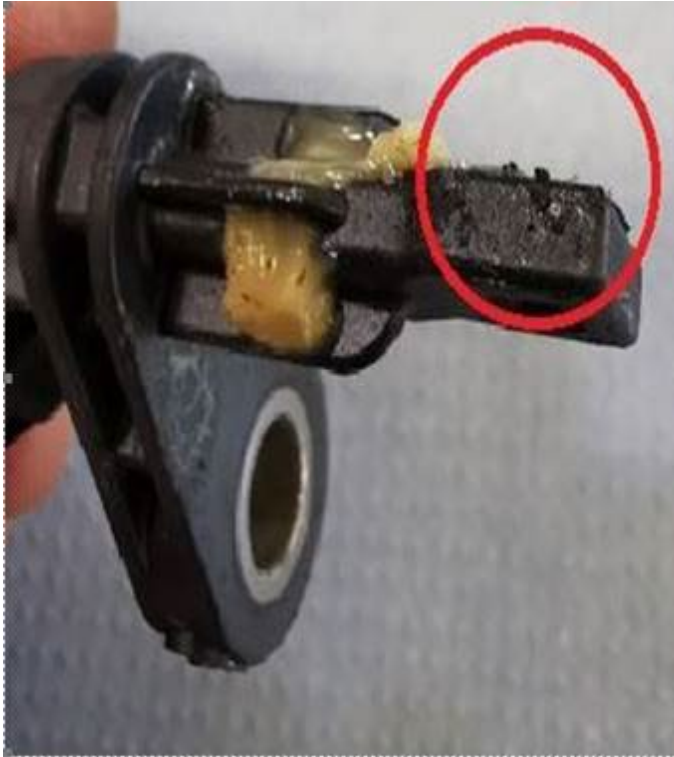
Foreign metallic particles in the area of the wheel speed sensor/wheel hub/wheel bearing/drive shaft (see figure 1, red circle) lead to implausible wheel speed signals.

*Figure 2: Metallic particles in the speed sensor.*

- a. Thoroughly remove foreign metallic particles from the components with workshop materials.
-

**Note:** Do not use magnetic tools to remove metallic particles from components.

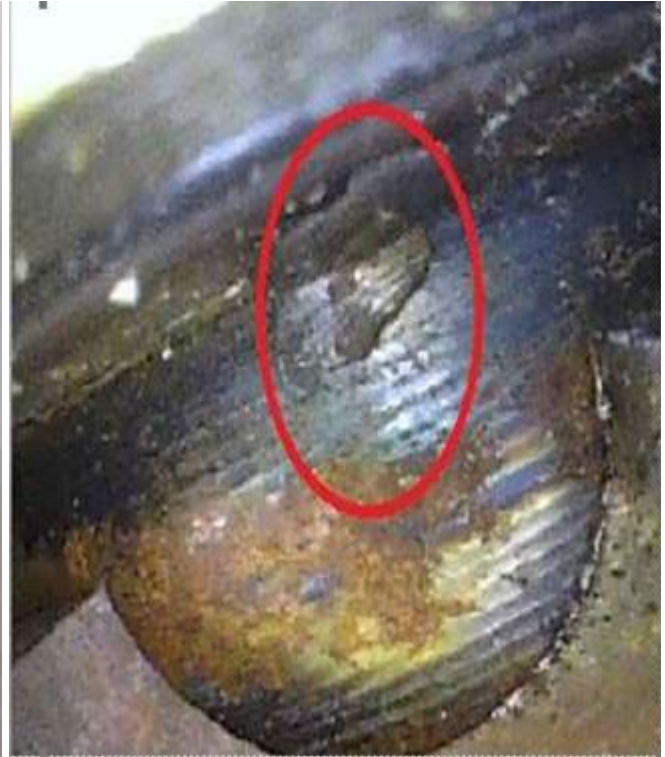
*Figure 3: Metallic particles in the hub.*

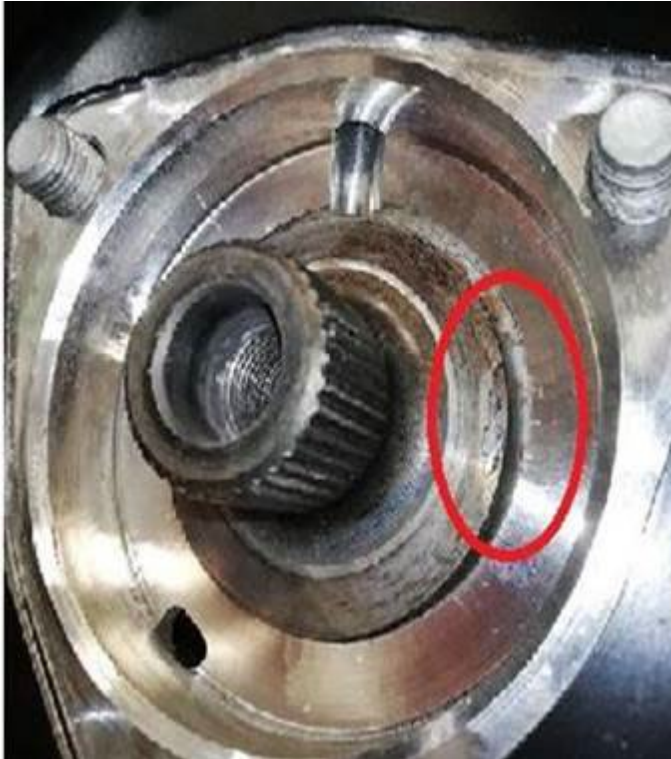
*Figure 4: Metallic particles/damage in the wheel hub/bearing.*

- b. Delete DTCs.
4. **Replace components (if necessary):**
- a. If there is damage to the components, replace them according to the Repair Manual (only if necessary).

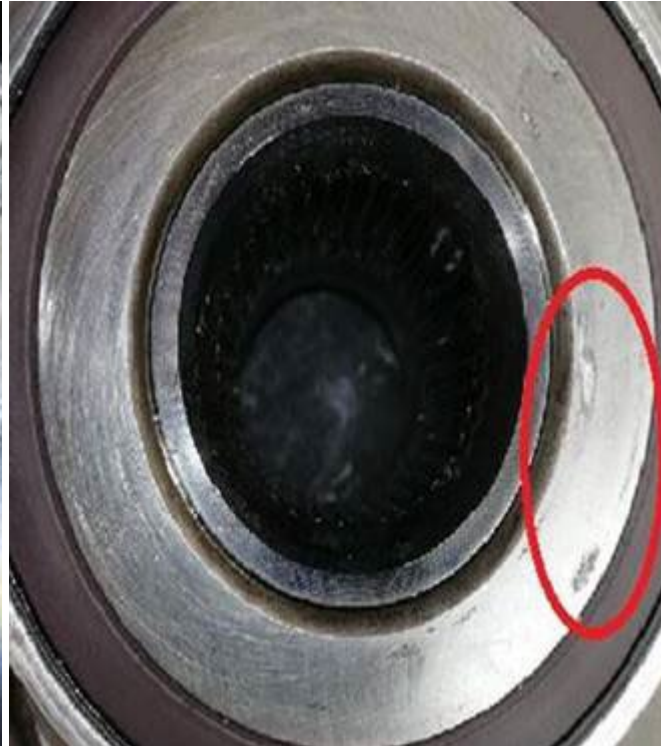
*Figure 5: Metallic particles/damage in the wheel hub/bearing.*
