Preliminary Information

PIP5651G Possible Charge Air Cooler Outlet Hose Disconnected From Throttle Body And One or More of The Following DTCs P0172, P0299, P0101, P0506, P1101

Proactive  
Product Investigation Review Required  
Models

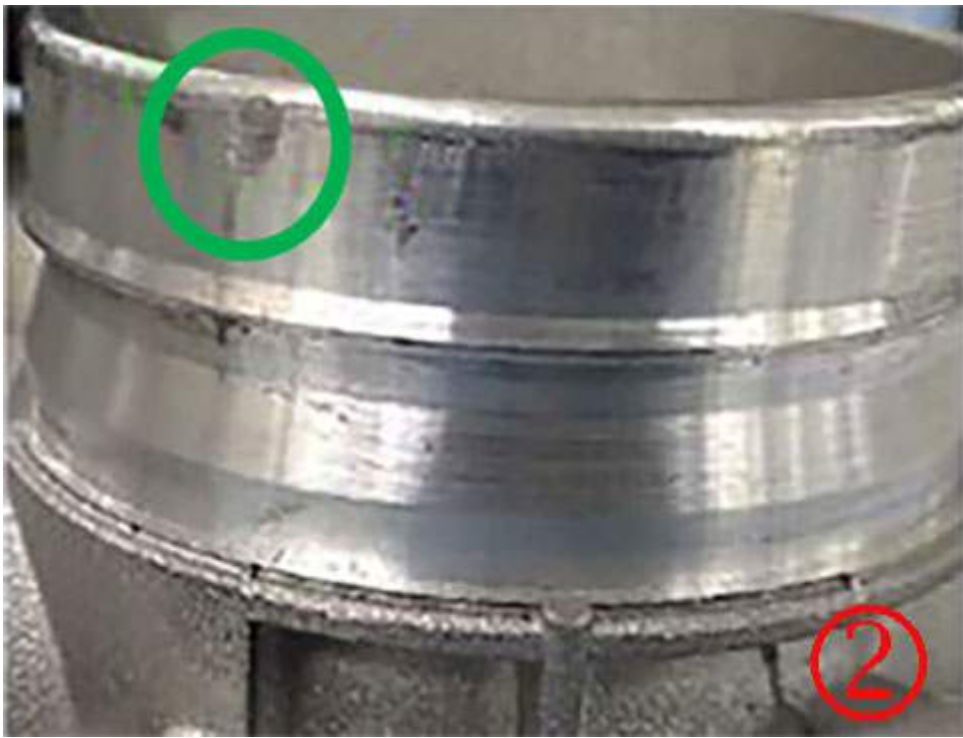
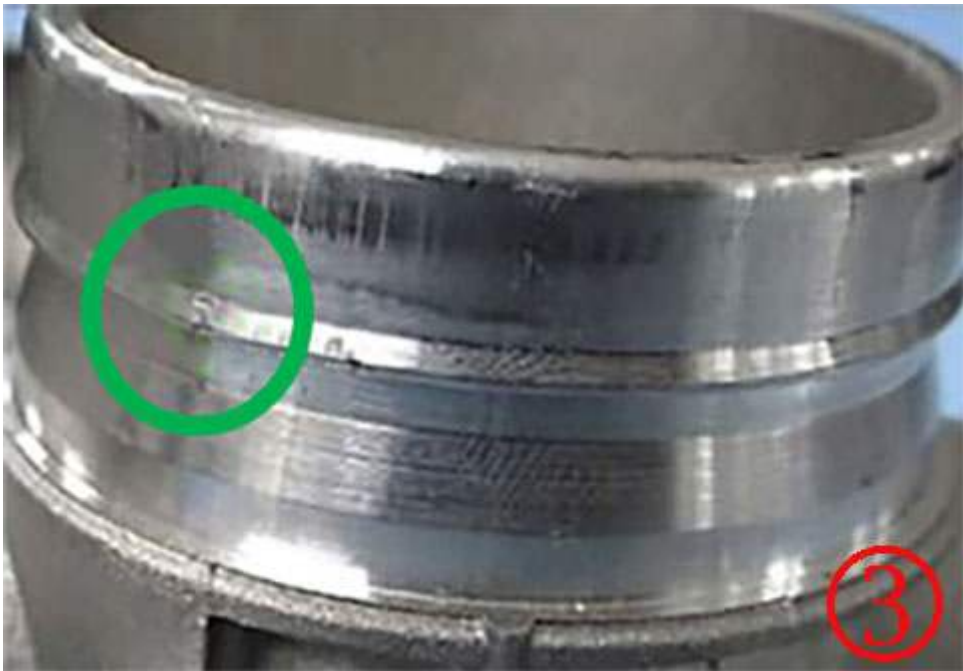
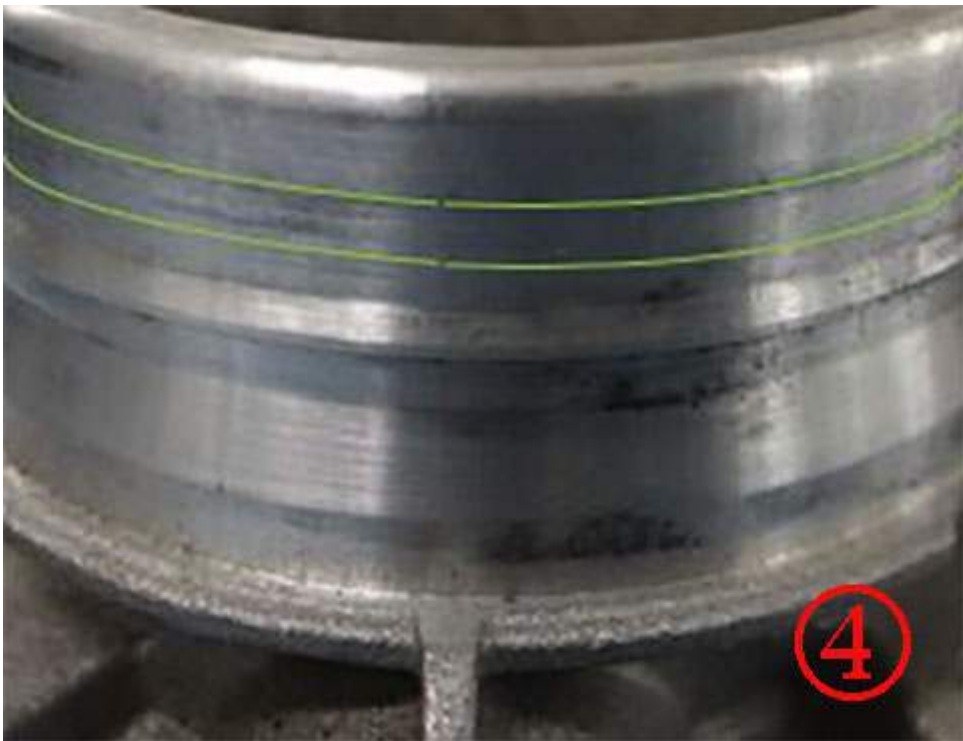
Photos 1-4 below show normal witness marks on the throttle body and normally will not require replacement.
