# Technical Service Bulletin

## 97 No start (DTC P068A00)

97 14 43 2036764/3 April 14, 2014. Supersedes Technical Service Bulletin Group 97 number 14-42 dated March 31, 2014 for reasons listed below.

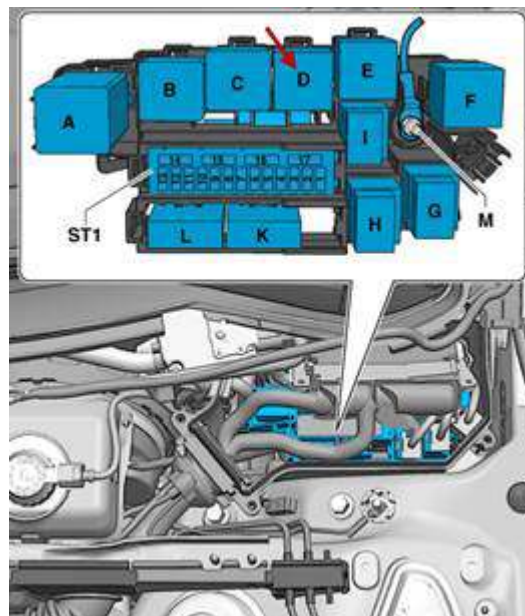
**Figure 1.** Location of J271 relay (D), as shown in Elsa.

2. Check Elsa for the location of the J271 relay (*Wiring diagrams* >> *Component locations* >> *Component Locations: Relays*) (Figure 1).

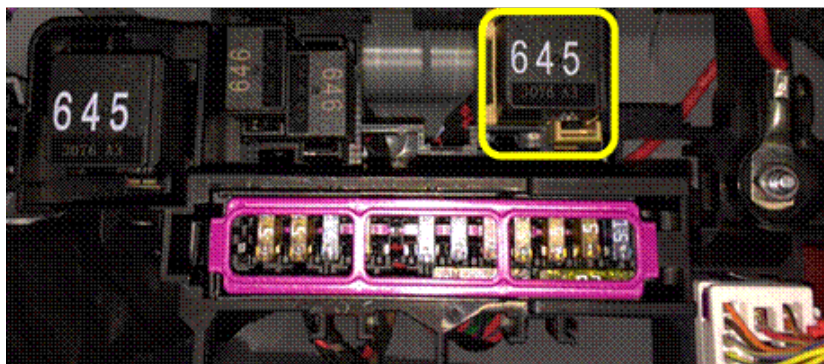
The motronic engine control module power supply relay, J271, is not functioning properly. Because the J271 relay controls battery voltage (Terminal 30) via a ground signal sent from the ECM, numerous faults can occur in multiple control modules when it is not functioning properly.

**Figure 6.** J271 relay (outlined).

7. The J271 relay is now accessible (Figure 6).

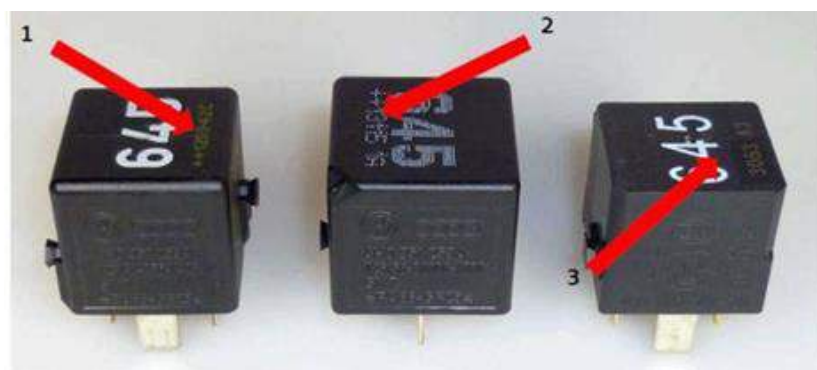
8. Check the relay manufacture build information on the relay. This information is printed under “645” on the relay:

**Figure 7.** Relay manufacture data: Tyco Electronics relay with a yellow label (1), Tyco Electronics relay with a white label (2), Hella relay with a white label (3).

- If the relay is from Tyco Electronics and has a yellow label (Figure 7, 1), replace the relay and proceed to step 10.
- If the relay is from Tyco Electronics and has a white label (Figure 7, 2) or from Hella and has a white label (Figure 7, 3), do not replace the relay. Proceed to step 9.

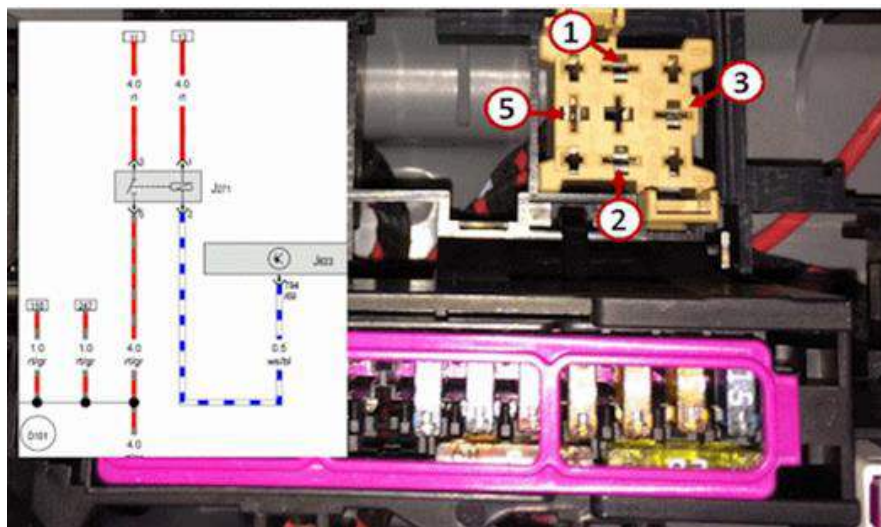
**Figure 8.** J271 relay pins. Terminal 1: 30 power from SA2, Terminal 2: switched ground from J623, Terminal 3: 30 power from SA2, and Terminal 5: switched power from J271.

10. Check for battery voltage on J271 relay harness terminals 1 (85 power) and 3 (30 power) (Figure 8 and Figure 9).

If no voltage is found, do not proceed with this bulletin. Continue with diagnosis.

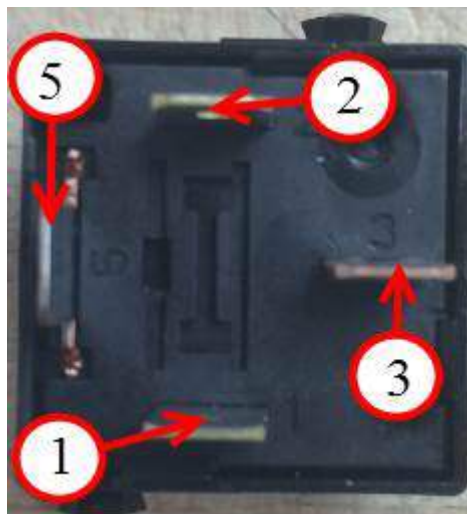
**Figure 9.** Relay terminal locations. Terminal 1: 85 Terminal 2: 86 Terminal 3: 30 Terminal 5: 87
