# Technical Service Bulletin

## 97 No start (DTC P068A00)

97 14 42 2036764/2 March 31, 2014. Supersedes Technical Service Bulletin Group 97 number 14-41 dated March 18, 2014 for reasons listed below.

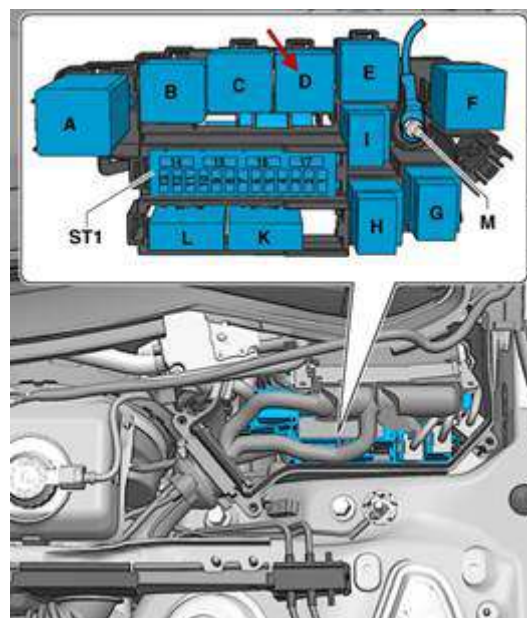
**Figure 1.** Location of J271 relay (D), as shown in Elsa.

2. Check Elsa for the location of the J271 relay (*Wiring diagrams* >> *Component locations* >> *Component Locations: Relays*) (Figure 1).

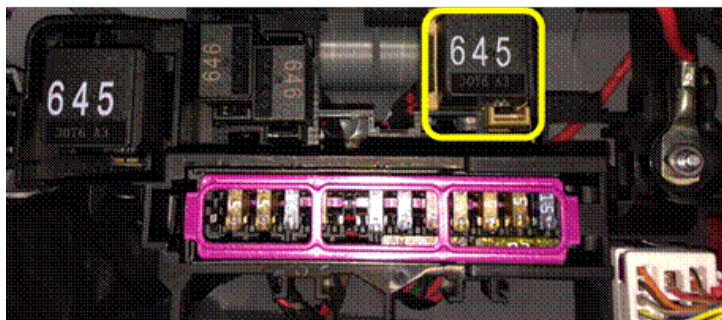
The motronic engine control module power supply relay, J271, is not functioning properly. Because the J271 relay controls battery voltage (Terminal 30) via a ground signal sent from the ECM, numerous faults can occur in multiple control modules when it is not functioning properly.

**Figure 6.** J271 relay (outlined).

7. The J271 relay is now accessible (Figure 6).

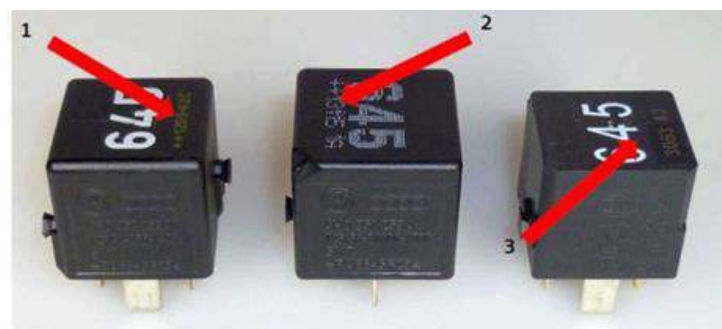
**Figure 7.** Relay manufacture data: Tyco Electronics relay with a yellow label (1), Tyco Electronics relay with a white label (2), Hella relay with a white label (3).

- If the relay is from Tyco Electronics and has a yellow label (Figure 7, 1), replace the relay and proceed to step 10.
- If the relay is from Tyco Electronics and has a white label (Figure 7, 2) or from Hella and has a white label (Figure 7, 3), do not replace the relay. Proceed to step 9.

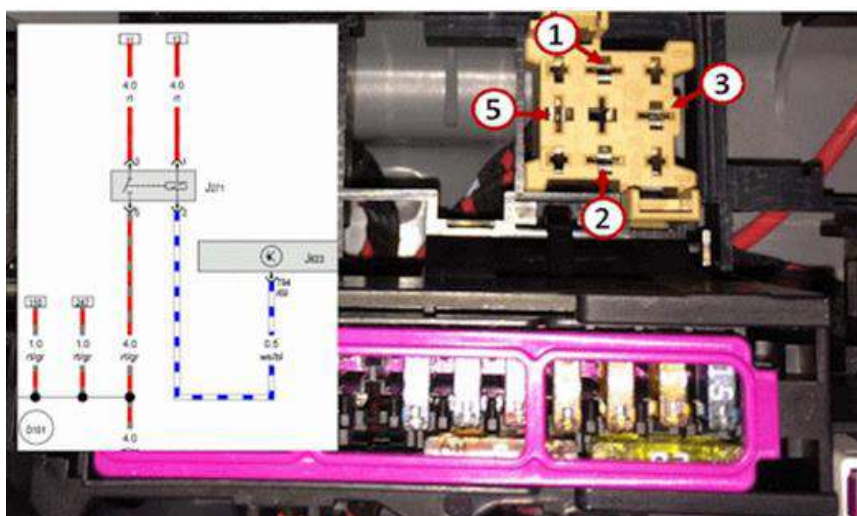
**Figure 8.** J271 relay terminals. Terminal 1: power from SA2, Terminal 2: switched ground from J623, Terminal 3: 30 power from SA2, and Terminal 5: switched power from J271.

9. Check the J271 relay according to the instructions in Elsa at: *Engine >> Generic Scan Tool >> ST Generic Scan Tool >> Diagnosis and Testing >> Diagnostic Procedures >> Engine Component Power Supply Relay, Checking.*
10. Check for battery voltage on J271 relay terminals 1 and 3 (Figure 8).

If no voltage is found, do not proceed with this bulletin.  
Continue with diagnosis.
