# Technical Service Bulletin

## 97 No start (DTC P068A00)

97 14 41 2036764/1 March 18, 2014.

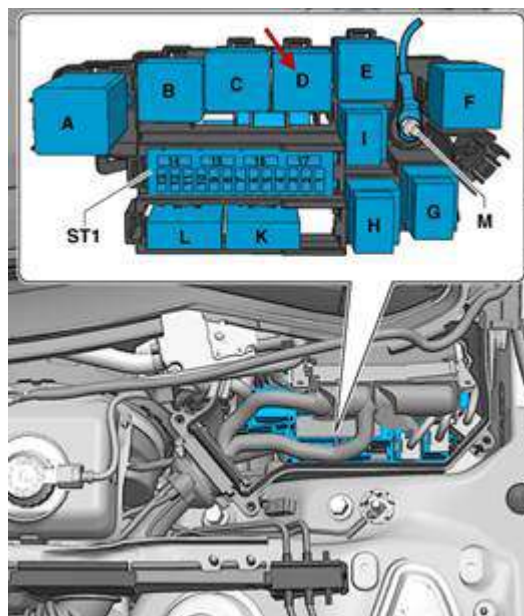
**Figure 1.** Location of J271 relay (D), as shown in Elsa.

2. Check Elsa for the location of the J271 relay (*Wiring diagrams >> Component locations >> Component Locations: Relays*) (Figure 1).

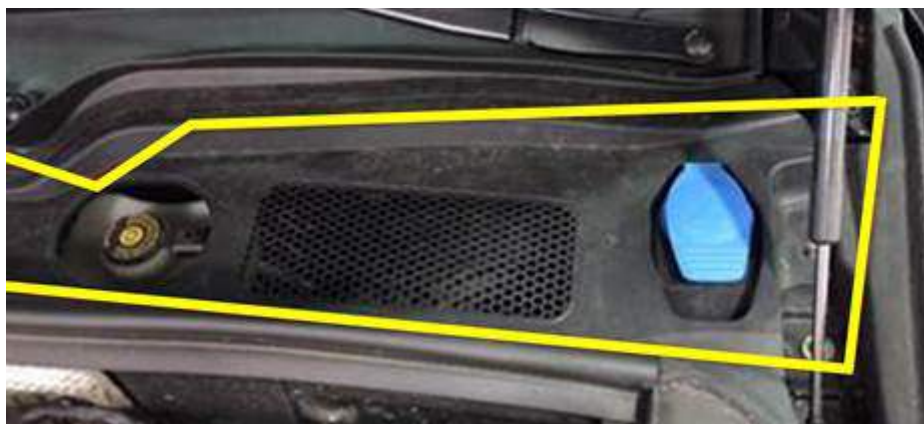
**Figure 2.** Plenum cover.

3. Remove the plenum cover (Figure 2).

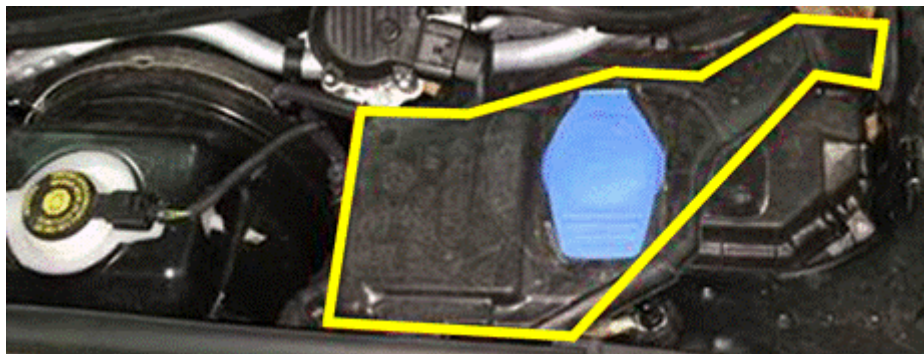
**Figure 3.** Washer reservoir fuel neck.

4. Remove the washer reservoir fuel neck (Figure 3).

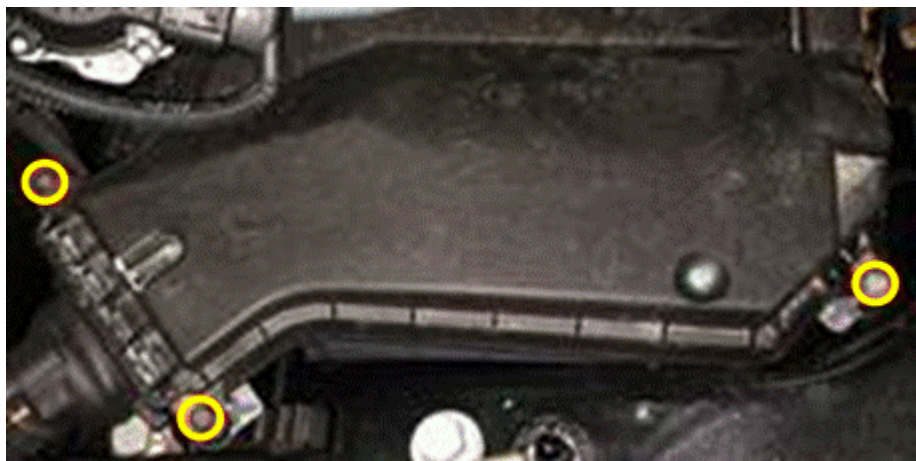
**Figure 4.** Screws to be removed (outlined).

5. Remove screws to gain access to the relay/fuse panel (Figure 4).

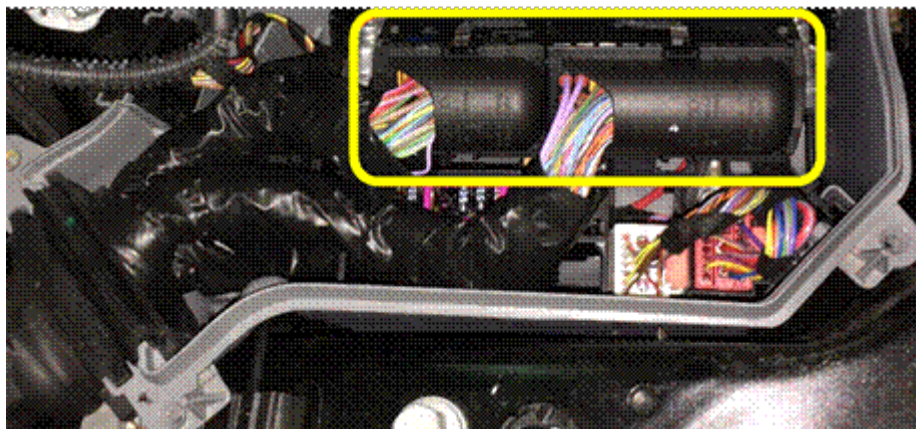
**Figure 5.** Engine control module (ECM).

6. Remove the ECM (Figure 5).

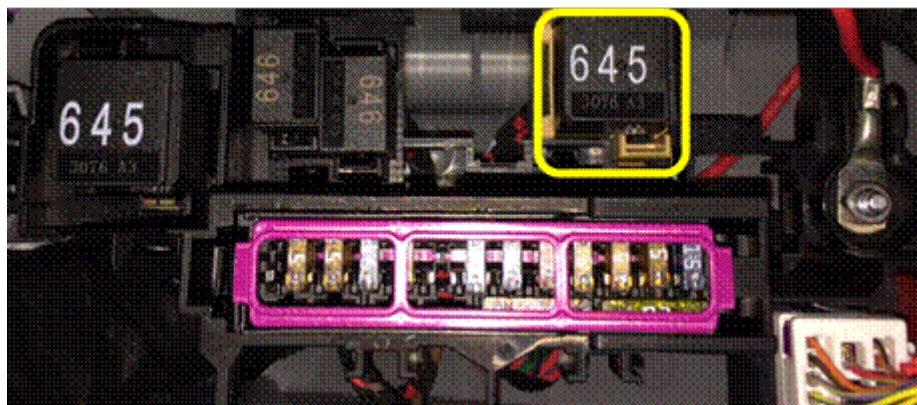
The motronic engine control module power supply relay, J271, is not functioning properly. Because the J271 relay controls battery voltage (Terminal 30) via a ground signal sent from the ECM, numerous faults can occur in multiple control modules when it is not functioning properly.

**Figure 6.** J271 relay (outlined).

7. The J271 relay is now accessible (Figure 6).

8. Check the J271 relay according to the instructions in Elsa at: *Engine >> Generic Scan Tool >> ST Generic Scan Tool >> Diagnosis and Testing >> Diagnostic Procedures >> Engine Component Power Supply Relay, Checking.*

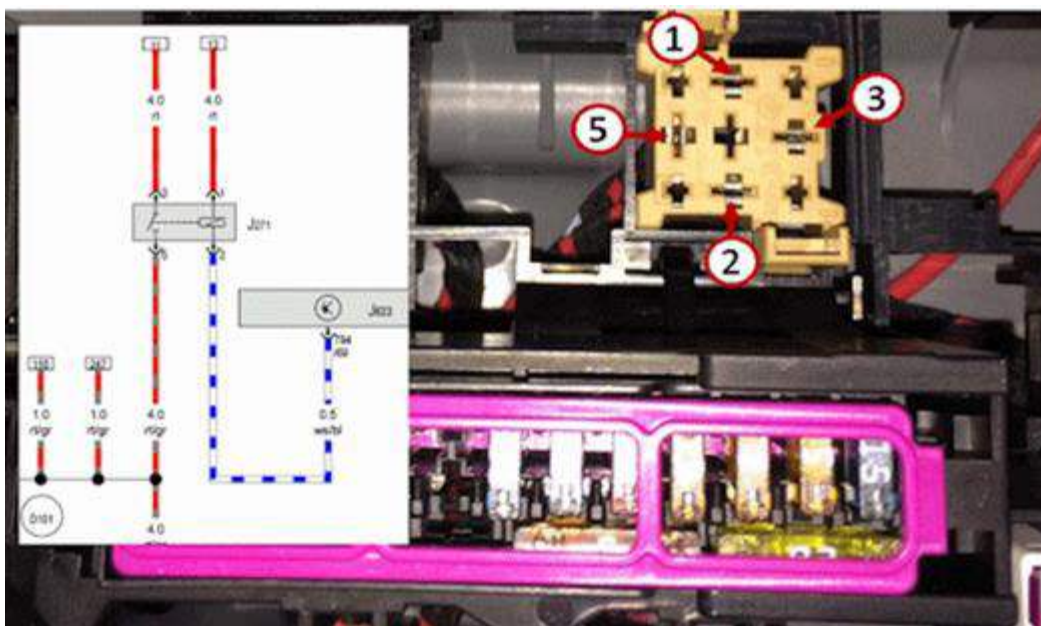
**Figure 7.** J271 relay terminals. Terminal 1: power from SA2, Terminal 2: switched ground from J623, Terminal 3: 30 power from SA2, and Terminal 5: switched power from J271.

9. Check for battery voltage on J271 relay terminals 1 and 3 (Figure 7).  
If no voltage is found, do not proceed with this bulletin. Continue with diagnosis.

10. With the ECM disconnected, check the wiring from J271 relay terminal 2 to the ECM:
- If voltage and wiring are good, replace the J271 relay.
  - If voltage and wiring are not good, do not proceed with this bulletin. Continue with diagnosis.
