# Technical Service Bulletin

## 96 Lane Change Assistant "Sensors Blocked" warning in DIS (DTC C1114F3 and C1115F5)

96 13 79 2035047/3 December 5, 2013. Supersedes Technical Service Bulletin Group 96 number 13-77 dated September 23, 2013 for reasons listed below.

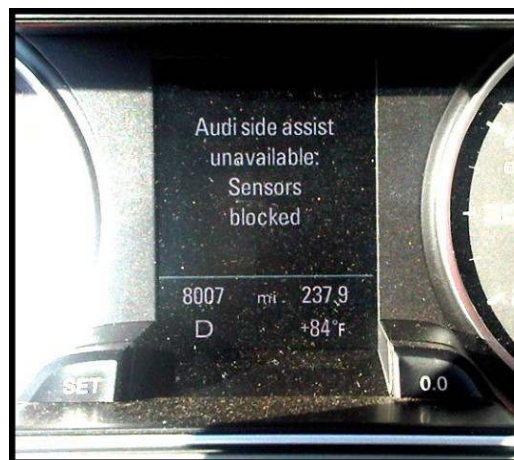
- Audi Lane Change Assistant deactivates or is sporadically inoperative when the vehicle is driven in slow-moving stop-and-go traffic, especially on roads with multiple lanes.
- The message “Audi side assist unavailable: Sensors blocked” appears in the driver information system (Figure 1).

**Figure 1.** Audi Side Assist warning in DIS

The software parameter update below will optimize the appearance of the “sensors blocked” message when the vehicle is driven in heavy stop-and-go traffic at low speeds. The updated parameter set will not remove the condition completely, as it is considered normal. The condition and the behavior of the system should be explained to the customer to prevent unnecessary repairs in the future.

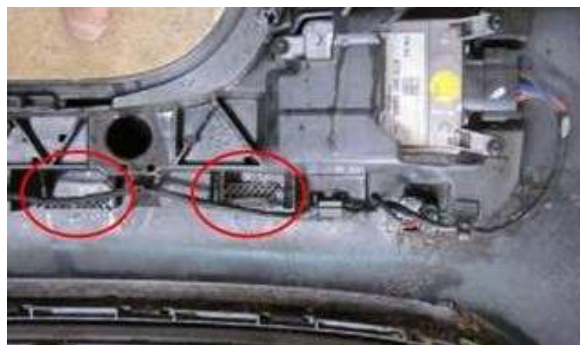
- One or both of the following DTCs is stored in the Lane Change Assistance control module, J769 (address word 3C):
  - **DTC C1114F3** (Lane change assistance control module Restricted view Sporadic)
  - **DTC C1115F5** (Lane change assistance control module 2 Restricted view Sporadic)
- Audi Lane Change Assistant can be activated without issue.
- No obstructions can be found on the outside or inside of bumper.
- No re-work of the bumper can be found (paint re-spray).
- The control module mounting brackets are securely fastened to the lower rear bumper, and no damage is found on the inside or on the outside rear bumper area (Figure 2).  
(If any damage is found, it is not covered under warranty.)

**Figure 2.** Mounting bracket for one of the ECUs.

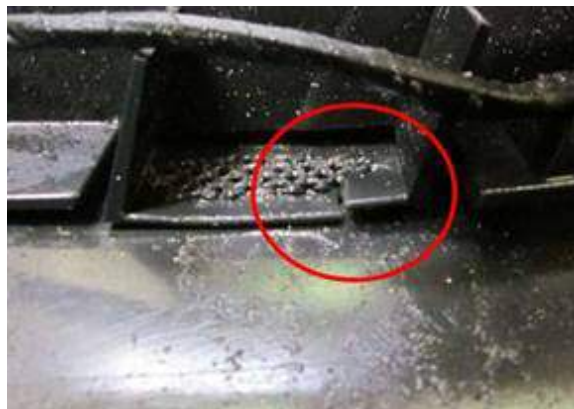
- The control module mounting brackets are not broken or loose (Figure 3 and Figure 4).  
(If any damage is found, it is not covered under warranty.)

**Figure 3.** Broken mounting bracket

**Tip:** If a loose bracket is found, repair as necessary using the Elsa Repair Manual. Submit a separate warranty claim, as this TSB does not cover this repair.

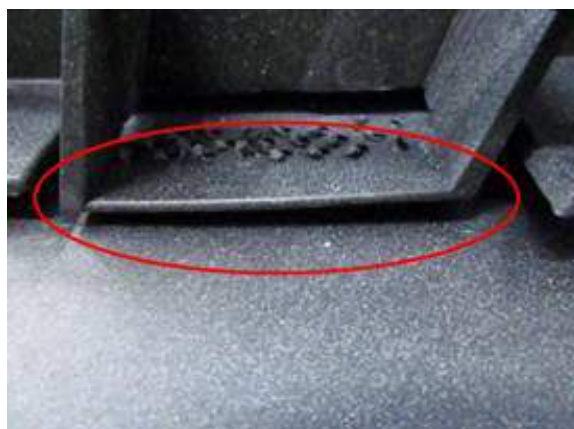
**Figure 4.** Loose mounting bracket.
