# Technical Service Bulletin

## 96 Lane Change Assistant "Sensors Blocked" warning in DIS (DTC C1114F3 and C1115F5)

96 13 77 2035047/2 September 23, 2013. Supersedes Technical Service Bulletin Group 96 number 13-72 dated August 26, 2013 for reasons listed below.

| Model(s) | Year | VIN Range | Vehicle-Specific Equipment |
|---|---|---|---|
| A4, A5, A5 Cab, allroad, Q5 | 2013-2014 | All | Audi Side Assist |

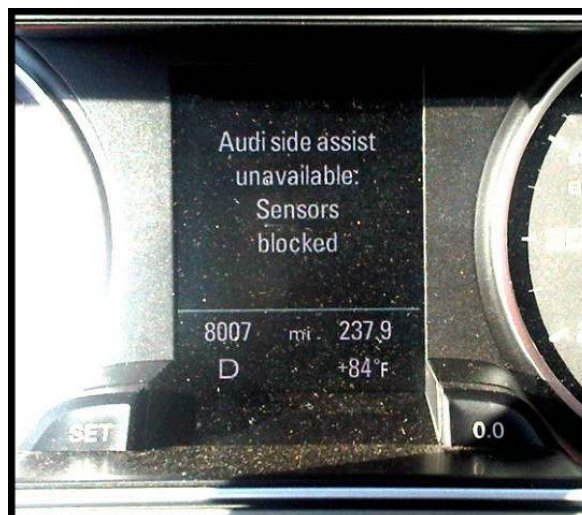
- Audi Lane Change Assistant deactivates or is sporadically inoperative when the vehicle is driven in slow-moving stop-and-go traffic, especially on roads with multiple lanes.
- The message "Audi side assist unavailable: Sensors blocked" appears in the driver information system (Figure 1).

**Figure 1.** Audi Side Assist warning in DIS

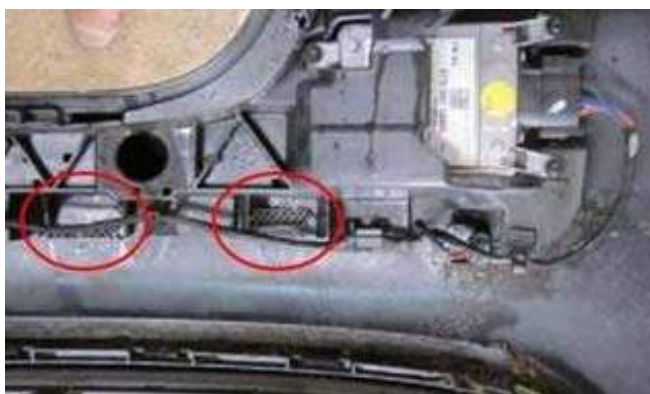
**Figure 2.** Mounting bracket for one of the ECUs.

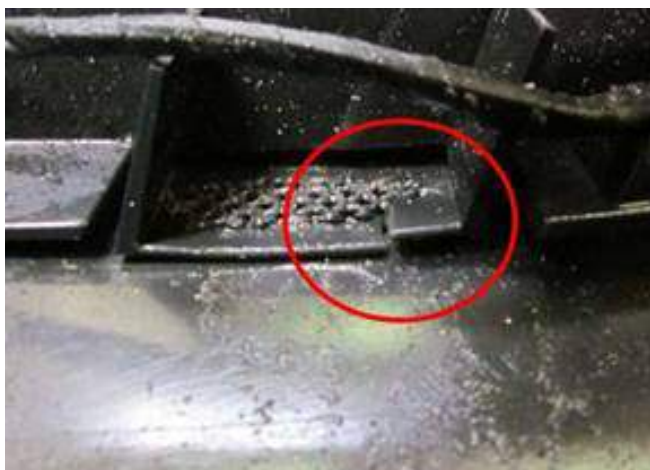
**Figure 3.** Broken mounting bracket

**Tip:** If a loose bracket is found, repair as necessary using the Elsa Repair Manual. Submit a separate warranty claim, as this TSB does not cover this repair.

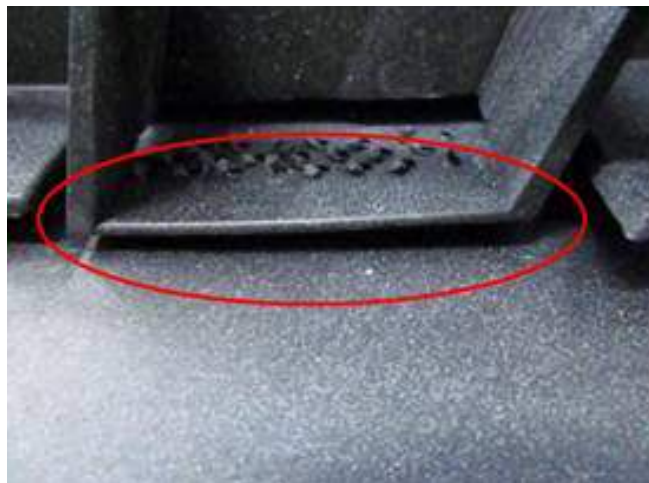
**Figure 4.** Loose mounting bracket.
