# Technical Service Bulletin

## 37 Incorrect coding in control module after software update (DTC P1749 stored in TCM)

37 14 36 2037151/1 July 14, 2014.

| Model(s) | Year | VIN Range | Vehicle-Specific Equipment |
|---|---|---|---|
| A8 | 2013 - 2014 | All | 4.0TFSI |

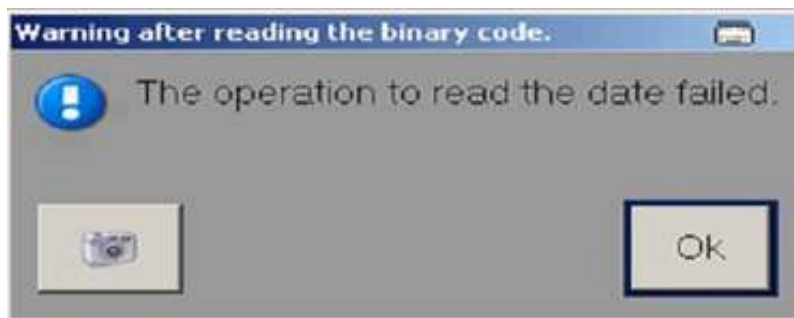
**Figure 3.** Warning message

6. A message appears with the warning: "The operation to read the date failed." (Figure 3). Select "Ok" to continue.
