## Technical product information

| <b>Topic</b> | Rotating display/screen - Fault diagnosis - Mechanical malfunction DTC B140107 is evident within 005F |
| <b>Brand</b> | Bentley |
| <b>Transaction No.</b> | 2067955/1 |

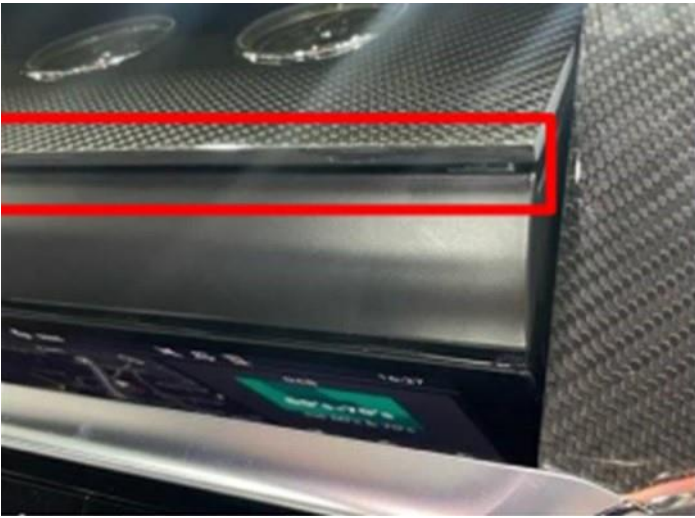
Figure 1

4) Conduct a visual check to ensure that the display clocks, dials fascia and veneer fascia are not unclipped from the rotating display assembly (Figures 1 and 2 show an example of the display clocks and/or dials fascia unclipped)

5) Referring to Rep.Gr91 - Remove the applicable fascia (Display clocks, dials fascia and/or Veneer fascia)

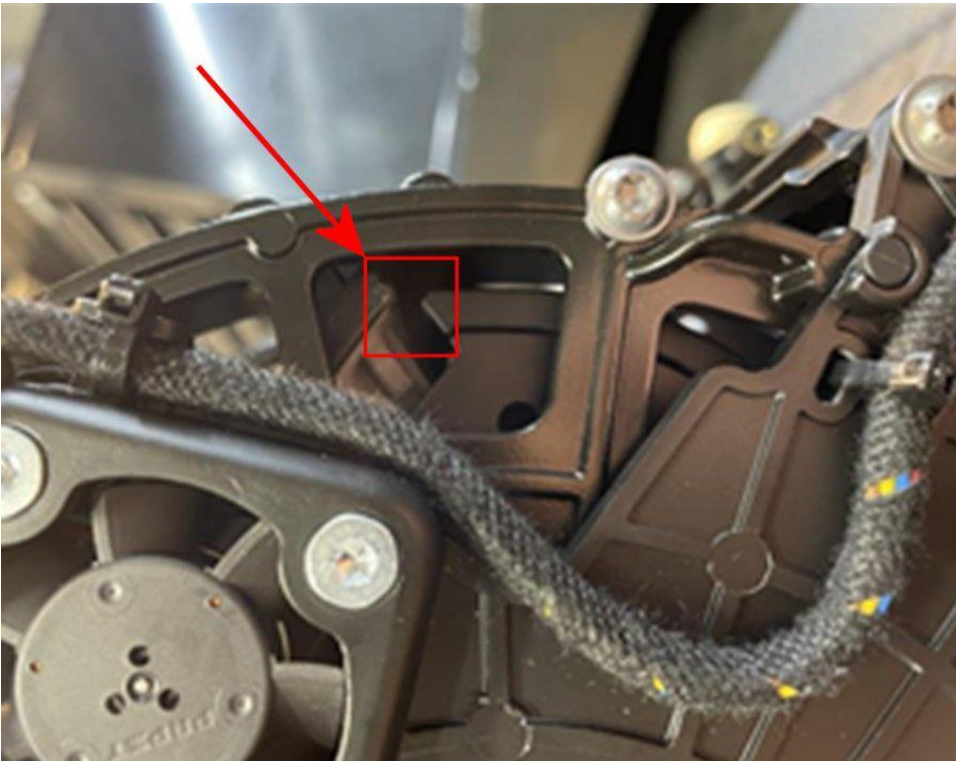
Figure 2

Please note: The BRD must be removed (Rep.Gr 91) to allow visual inspection of the panel at the back of the BRD for signs of unclipping (Figure 2)

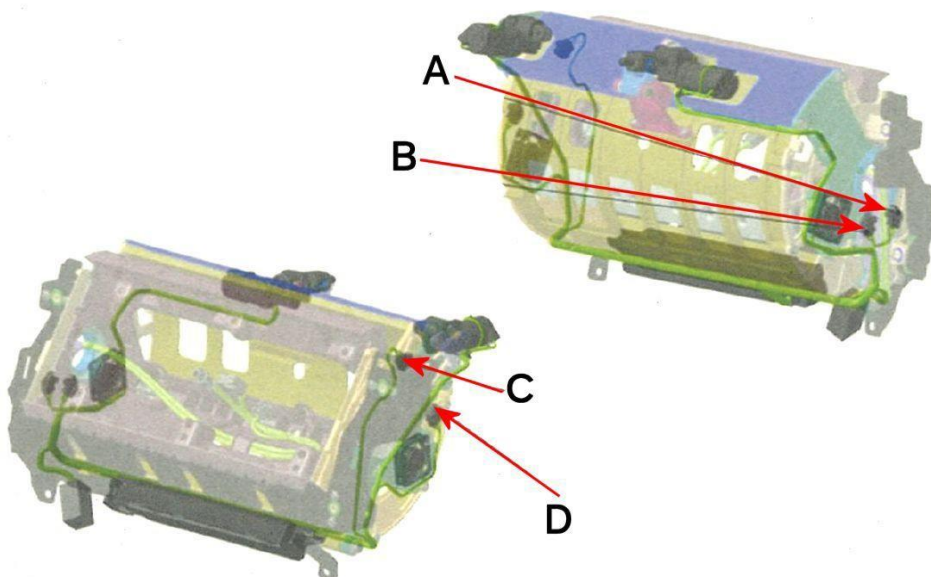
Figure 4 shows the location of each BRD switch (A to D) as follows: A

- Rotational gauge fascia position

B - Rotational veneer fascia position

C - Longitudinal deployed position

D - Longitudinal rotation position

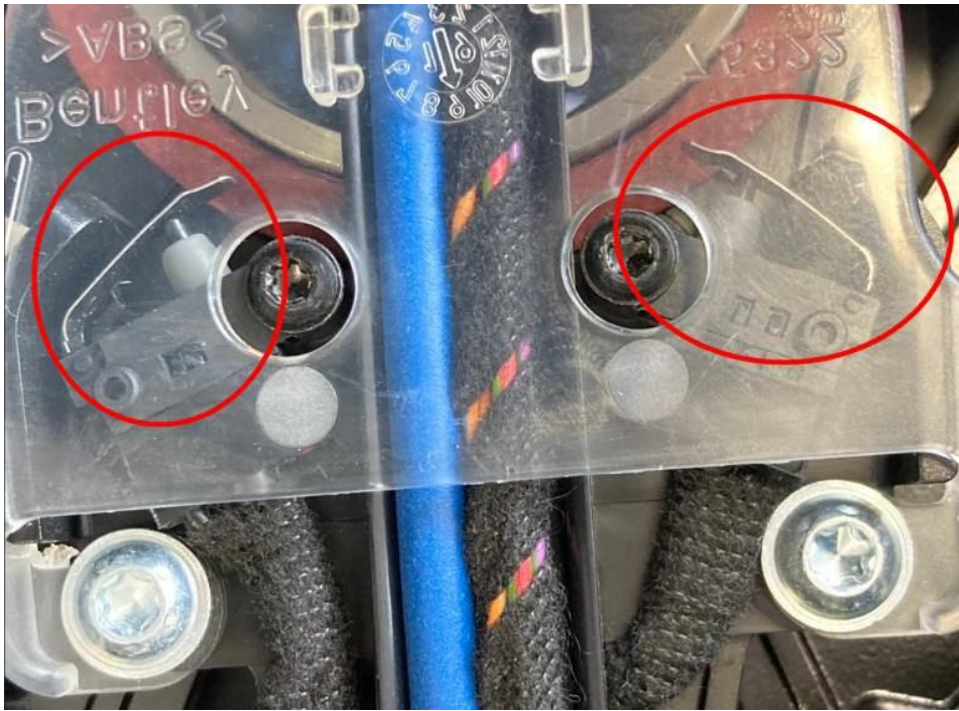
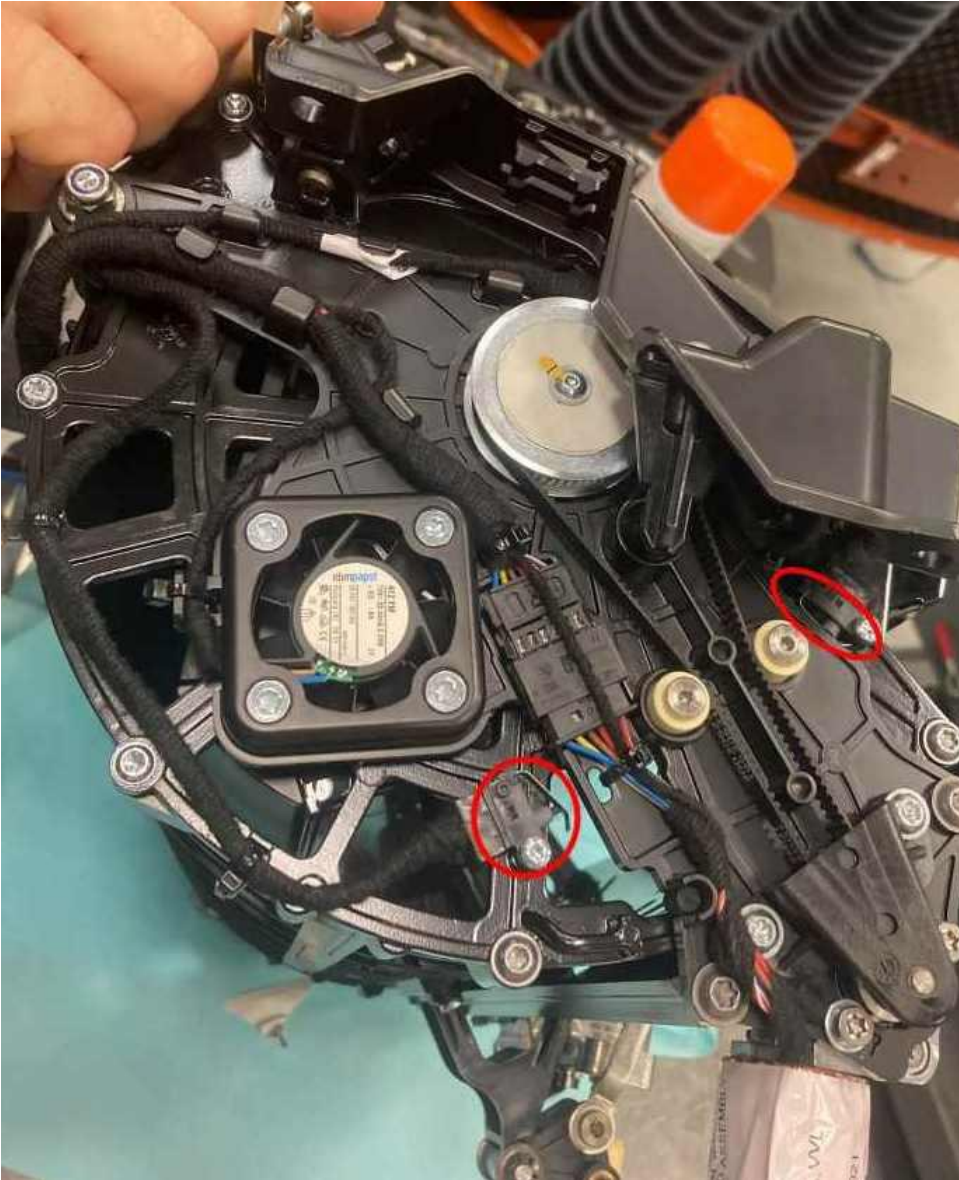
Referring to Figures 5 and 6 check/confirm the condition of the micro switches checking for any abnormalities for example damage and/or striker misalignment

Please note: The micro switch examples shown in Figures 5 and 6 are to specification

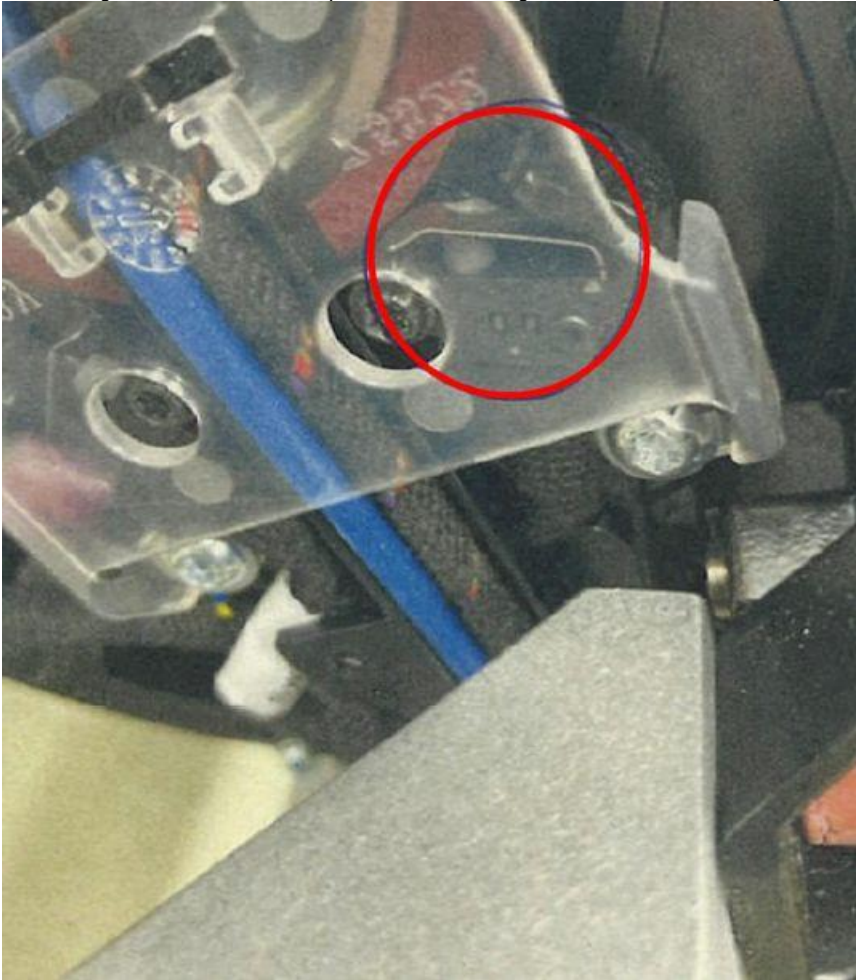
NOTE: Figure 7 shows an example of striker misalignment and switch damage

- Once the afore mentioned work has been conducted successfully - Referring to Rep.Gr 91 - Refit the BRD

NOTE: Should any of the previously suggested steps not have been successful please raise a new Technical DISS query or respond via an existing query ensuring all images and videos of the issue including the battery test results and a current ODIS log are attached and await feedback before conducting any further work
