## Technical product information

| <b>Topic</b> | Bentayga - Air suspension warning light within the DIP - DTC's P089200 - C104707 - C103B13 - Evident within Address 74 |
| <b>Brand</b> | Bentley |
| <b>Transaction No.</b> | 2062261/4 |

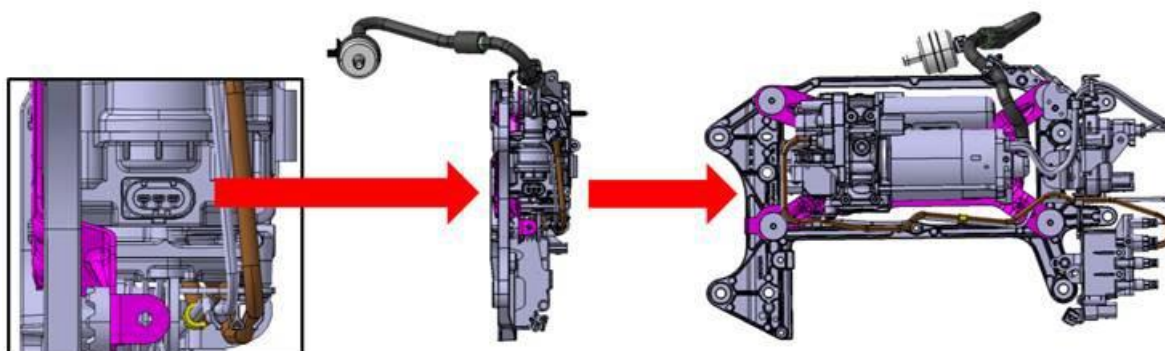
NOTE: NX7 is located as shown in Figure 1 (On the air supply unit/opposite side to the valve block)

- Conduct a wiring integrity check between the Valve block for adaptive suspension control unit (NX7) and the Running gear control unit (J775)
