## Technical product information

| <b>Topic</b> | EPB Warning light in DIP - Front door/s power latch system intermittent - DTC U112300 within Address 03 and Address 46 |
| <b>Brand</b> | Bentley |
| <b>Transaction No.</b> | 2055883/2 |

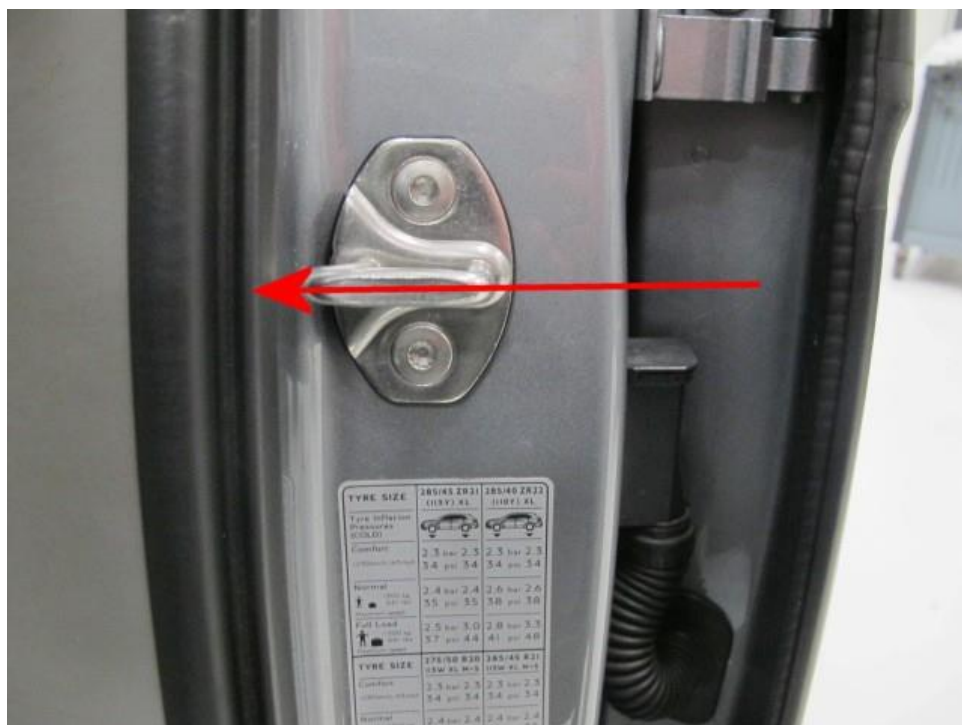
Figure 1

The front door/s power latching system sporadically does not work. The door remains in the first latch of the door lock and is not closed by the power latching system

The micro switch signal of the door lock is not recognised or too briefly

A counter-pressure of the door is required to clearly recognise the signal

- 1) Check whether the striker runs into the centre of the rotary latch of the door lock and correct it if necessary - Refer to Rep.Gr 57 - Door striker  
- To remove and fit

In addition, adjust the striker as far as possible (at least 0.5 mm) further inwards (Figure 1)
