# Technical Service Bulletin

SCBS WARNING LIGHT WITH DTC U045A:68 AND/OR PARKING  
SENSOR INDICATOR FLASHING WITH DTC B1B36, B1B38,  
B1B40 AND/OR B1B42

Bulletin No.: 15-002/22

2017-**2023** CX-5 with front parking (ultrasonic) sensor

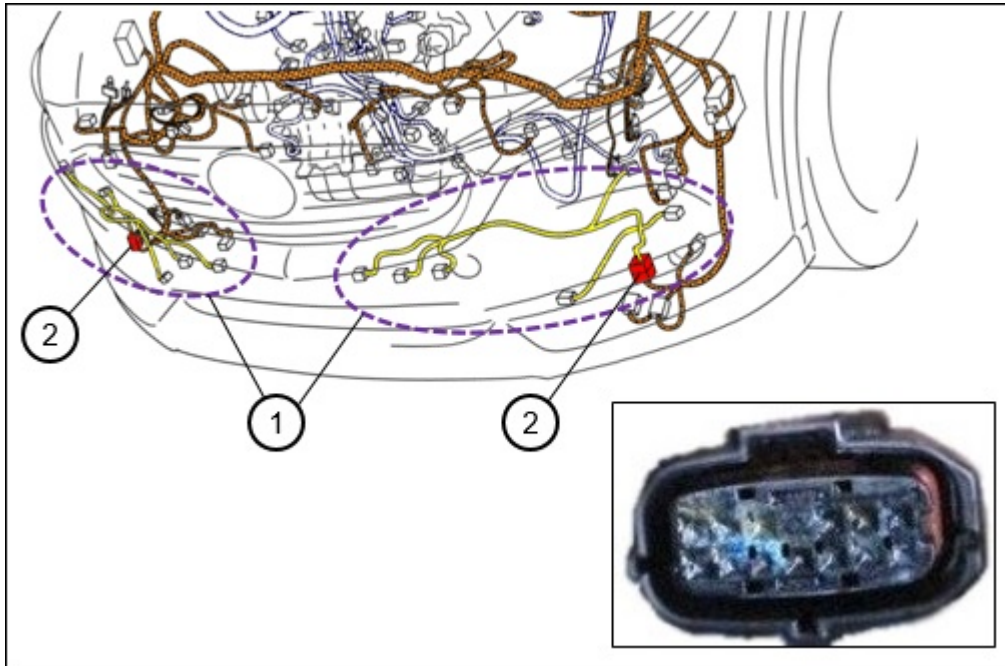
Due to insufficient waterproof performance of the front harness short cords (1), water may enter in and accumulate in the C-11 (LH) or C-12 (RH) connectors (2) causing a short circuit between wires and an improper signal being sent from the parking (ultrasonic) sensor to the parking sensor unit.

Sample picture shows C-11 connector with water entry and terminal corrosion.

To eliminate this concern, the production process of the front harness short cord has been improved to increase waterproof performance.
