# Technical Service Bulletin

87 Air conditioning does not cool - P053000, P251500 stored in C5

87 22 35 2068460/1 November 9, 2022.

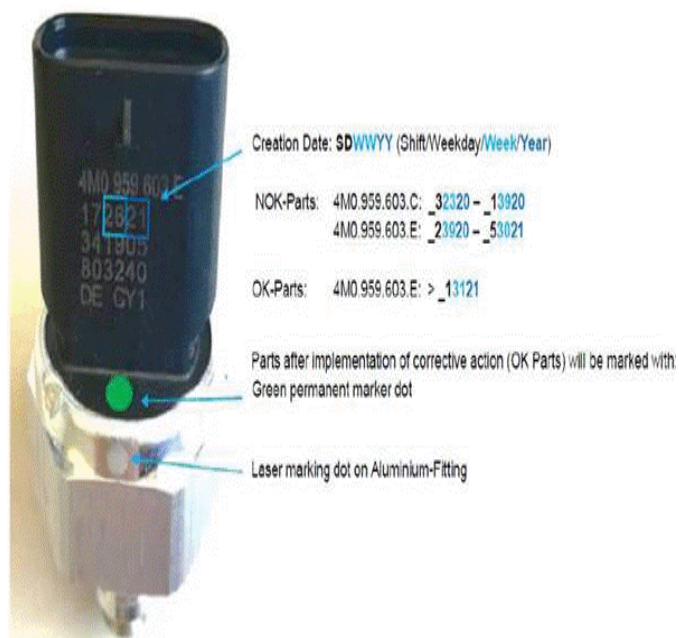
**Figure 1.** Pressure and temperature sensor markings and build date.

A failure of the sensor electronics causes a loss of pressure evaluation. The sensor with base part number 4M0959603 and a build date before the date Calendar Week 31, 2021 is at issue (G395 / G827).

2. Inspect the markings on the sensor to determine if the sensor has been previously replaced with an improved sensor produced after Calendar Week 31, 2021. Figure 1 shows the locations of the markings and their interpretation. In this example while the sensor is an 'E' index sensor, contains a green dot on the connector housing and a laser marking on the aluminum housing the build date of the sensor is *before* Calendar Week 31, 2021 and would require replacement.

1. Should the vehicle present with the symptom profile described in this TSB inspect and/or replace all of the pressure sensors in the refrigerant circuit that are of the base part number 4M0959603 and have a build date before Calendar Week 31, 2021. Each model for which this TSB appears will have between 1 and 3 of this type of sensor installed at various positions in the refrigerant circuit, either on the low or high pressure sides of the circuit (G395 / G827).

3. A sensor with index 'E', produced after Calendar Week 31, 2021, has a green dot on the connector housing and has a laser marking on the aluminum housing are of the improved type and need not be replaced.
