## Technical product information

| <b>Topic</b> | V8 Kovomo - Engine MIL light on - DTC 'P04F000: EVAP system high pressure purge line performance' evident |
| <b>Brand</b> | Bentley |
| <b>Transaction No.</b> | 2065148/2 |

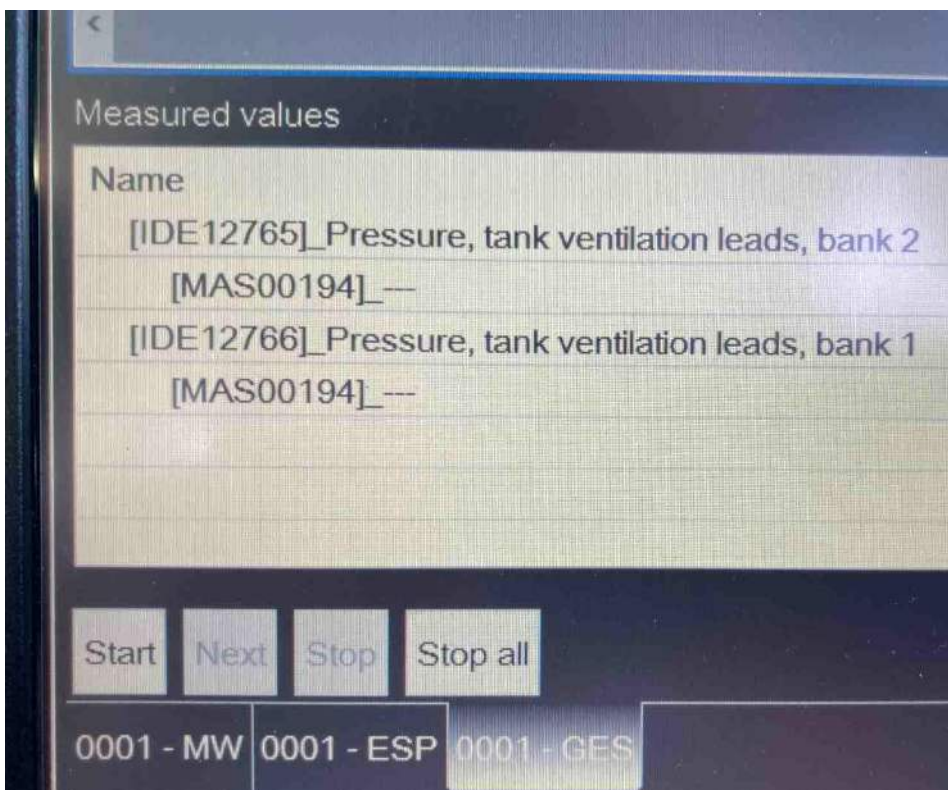
Figure 1

IDE12765 (When monitored) fluctuates from the static value found (Ignition on/Engine Off) Or

With/without purge activation

IDE12766 (When monitored) DOES NOT fluctuate from the static value found (Ignition on/Engine Off) Or

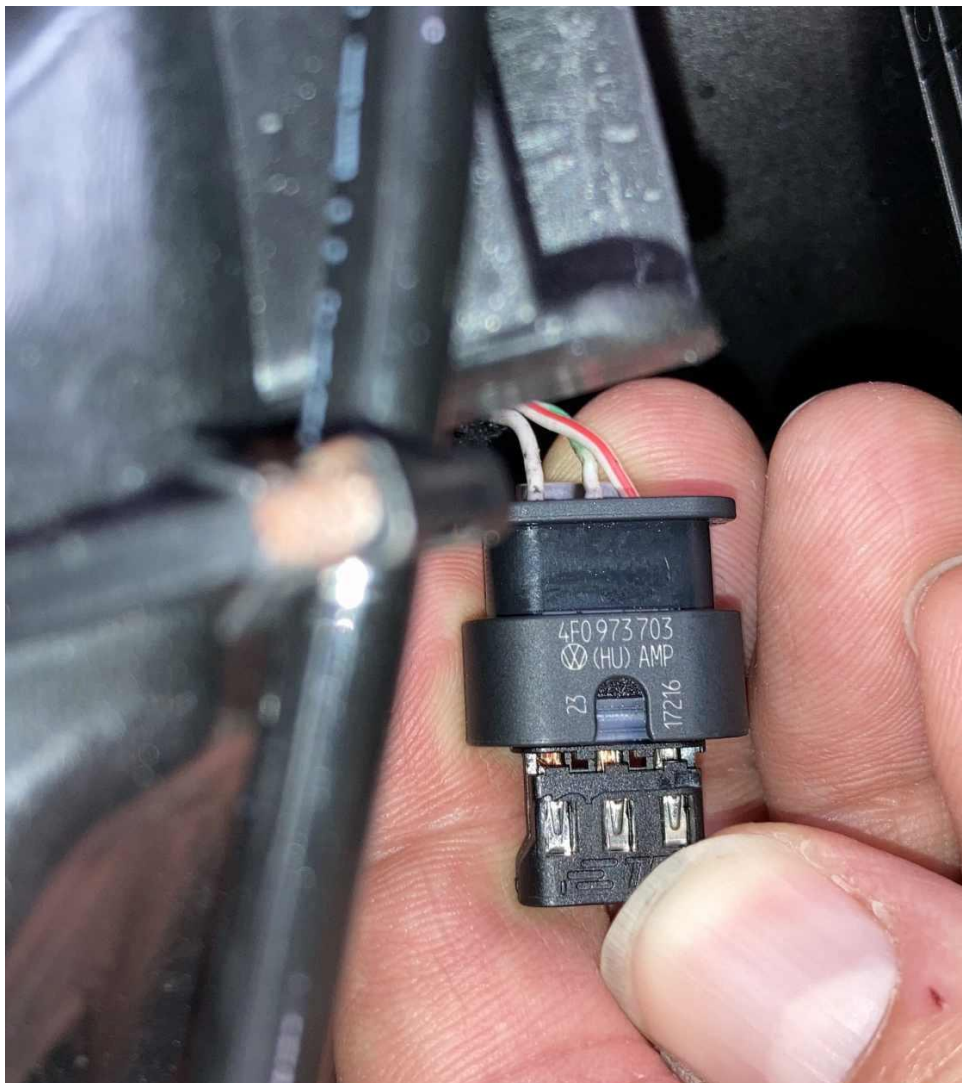
TIP: As both wires are white, the green line which can be seen on the central white wire was applied to aid the operative when swapping the PIN's to the correct locations

2) Referring to Figure 3 and the attached PDF instructions - De-pin/Remove PIN's 1 and 2 from connector T3dd

3) Install PIN 2 into PIN 1

4) Install PIN 1 into PIN 2

5) Conduct a wiring integrity check from T3dd (PIN's 1 and 2) - To Connector T56aj (PIN's 1 and 5)
