**MAZDA CONNECT INTERMITTENT AUDIO NO SOUND AND/OR  
STATIC NOISE FROM SPEAKERS**

**Service Alert No.: SA-070/22**

2020-2023 CX-30

2019-2023 Mazda3

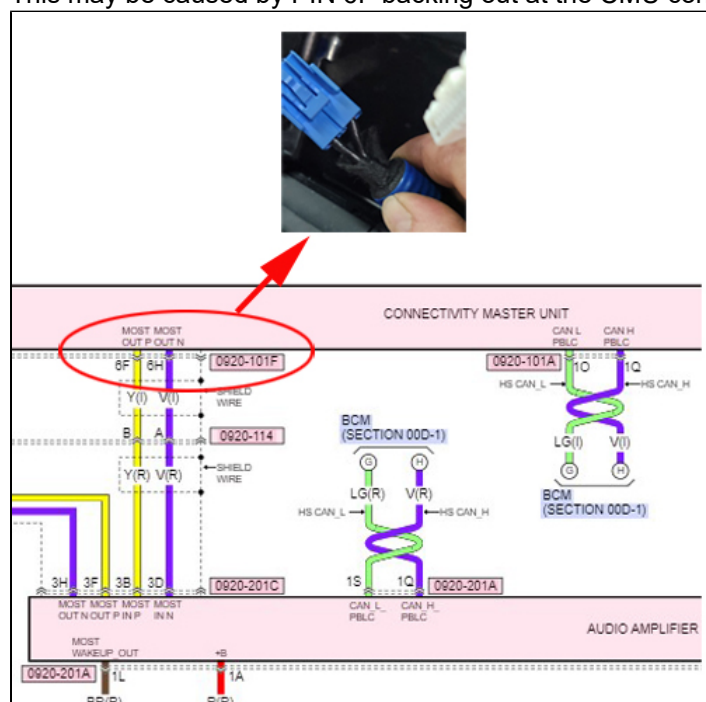
This may be caused by PIN 6F backing out at the CMU connector 0920-101F.

1. Verify the customer concern.
  2. Disconnect the Instrument Panel Harness connector 0920-101F (CMU connector).
  3. Remove pins 6F and 6H from the MOST output connector 0920-101F.
  4. Untwist pins 6F and 6H (straighten) and reinstall them into connector 0920-101F.
- NOTE:** You may need to remove about 1/2 of the insulation to give more flexibility/slack.
5. Pull on pins 6F and 6H to confirm they are locked and secured.
- NOTE:** If the harness connector cannot be repaired, replace the Instrument Panel Harness.
6. Clear any DTC's.
  7. Verify the repair.

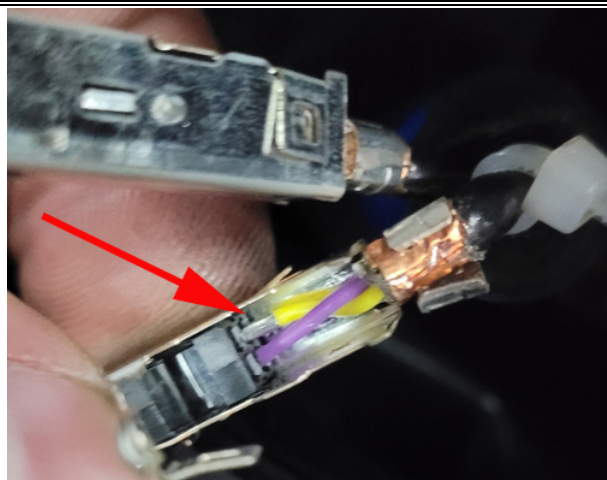
PIN 6F is backed out

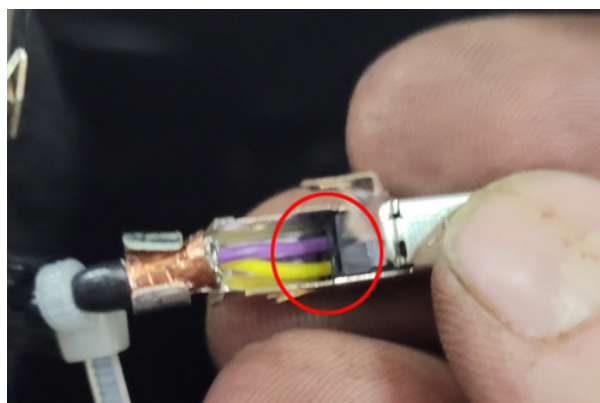
PIN 6F is untwisted and repaired
