# TECHNICAL SERVICE BULLETIN

## Illuminated ABS Indicator, Engine Will Not Turn Off And/Or Various Electrical Symptoms

**22-2443**

Ford  
2020-2022 F-Super Duty

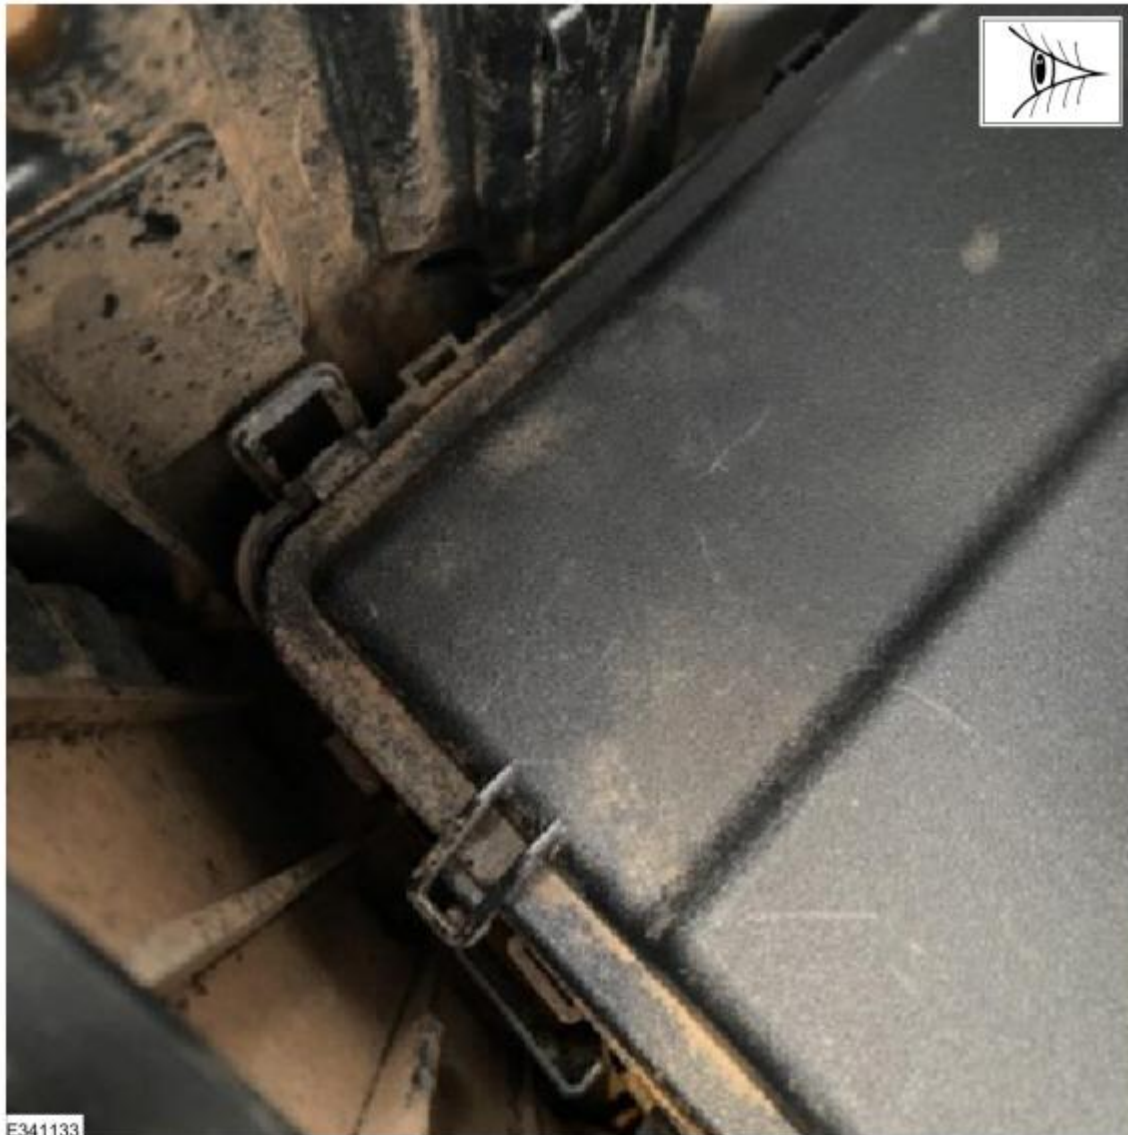
Figure 1 - Example of moisture intrusion with BJB cover on

### 3. Replace the BJB assembly and cover.

- (1). Remove the battery and battery tray. Refer to the Workshop Manual, Section 414-01.
- (2). Remove the BJB cover.
- (3). Loosen the 2 BJB connector bolts and remove the battery power cable nut. Disconnect the battery power cable from the BJB.

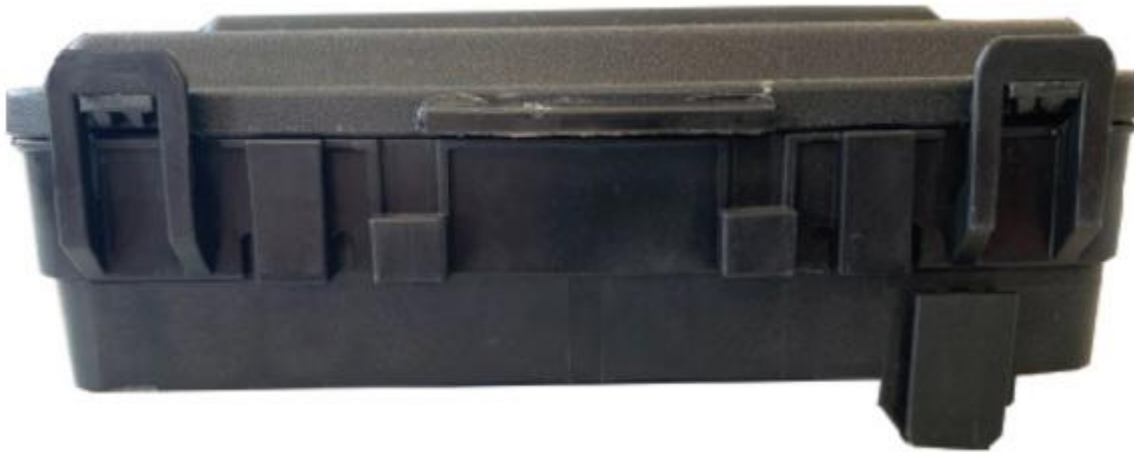
E341135

Figure 3 - Correct cover installation

- (9). Install the new BJB cover making sure the cover tabs/locking fingers are installed correctly.
- (10). Install the battery tray and battery back into the vehicle. Refer to WSM, Section 414-01.
