| <b>Topic</b> | DTC P1B8100 stored within 006B – Aerodynamic control unit - No test plan in ODIS to assist with diagnosis |
| <b>Brand</b> | Bentley |
| <b>Transaction No.</b> | 2068151/2 |

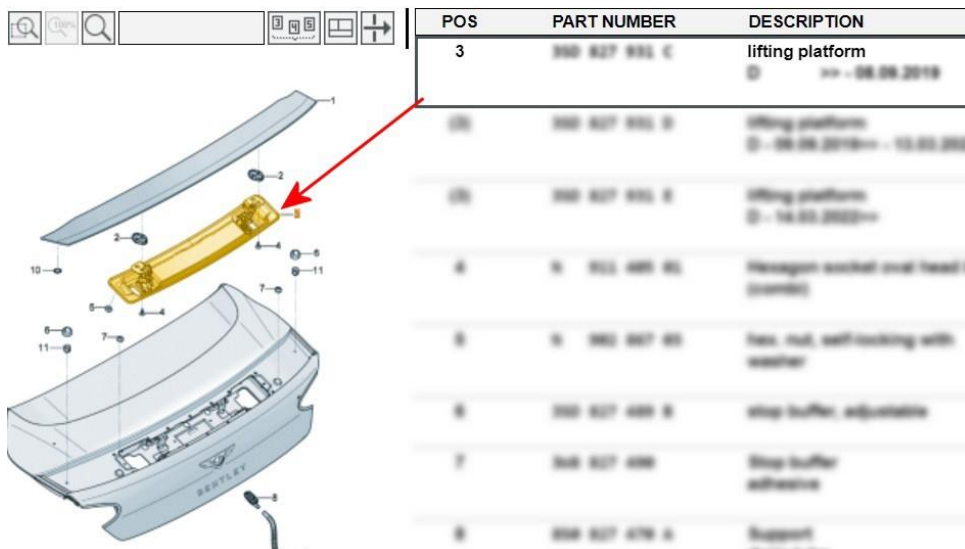
Figure 1

Refer to the ETKA parts catalogue for the deployable rear spoiler assembly (lifting platform as Figure 1) part number

- Should no wiring issues be evident - Referring to Rep.Gr 66 replace the deployable rear spoiler assembly
