| <b>Topic</b> | New Continental GT and GTC - Window drop glass concerns |
| <b>Brand</b> | Bentley |
| <b>Transaction No.</b> | 2067436/5 |
| <b>Release date</b> | 04-Nov-2022 |

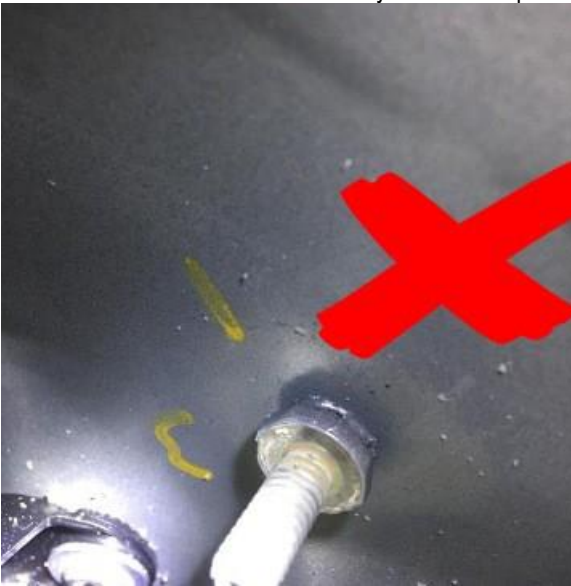
- Earth point 736 RHR and Earth point 738 LHR
- Check for cleanliness and security of both earth points Figure 2 shows an example of a contaminated earth point (dirt/paint/debris)

- Remove any dirt/paint/debris from the earth points using suitable abrasives/wire brush ensuring no damage is caused to the earth stud threads as shown in Figure 3

- Secure the earth point fixings to (9Nm)

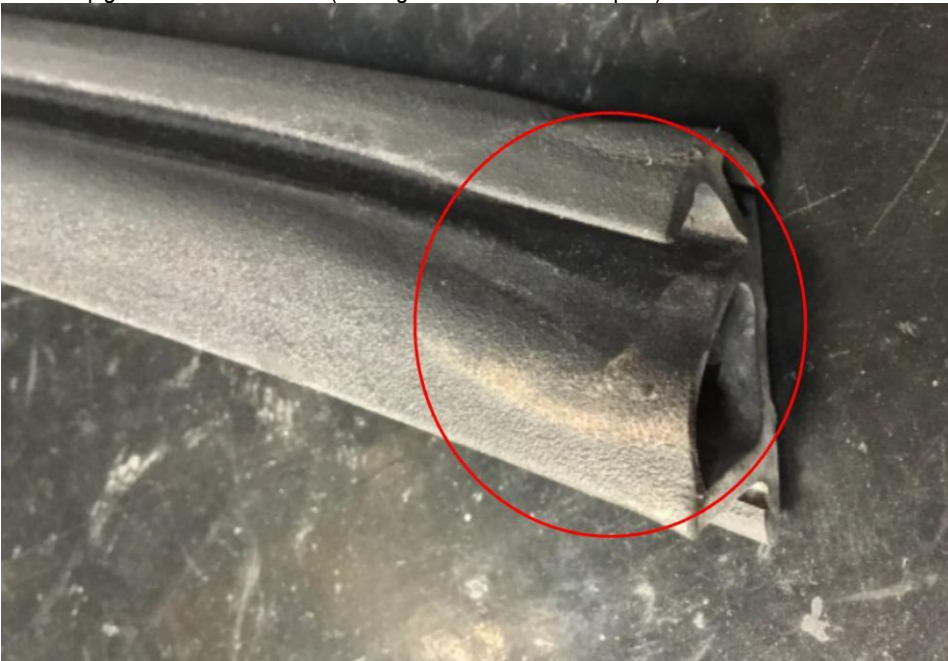
Figure 4

- Damage
- Splits
- Tears
- Misalignment
- Incorrectly fitted/located
- Drop glass seal deformation (see Figures 4 and 5 as examples)

NOTE: Any issues found with the window seals must be rectified before conducting the remaining steps
