## Technical product information

| <b>Topic</b> | Air suspension warning light within the DIP - DTC's P089200 - C104707 - C103B13 - Evident within Address 74 |
| <b>Brand</b> | Bentley |
| <b>Transaction No.</b> | 2062259/5 |

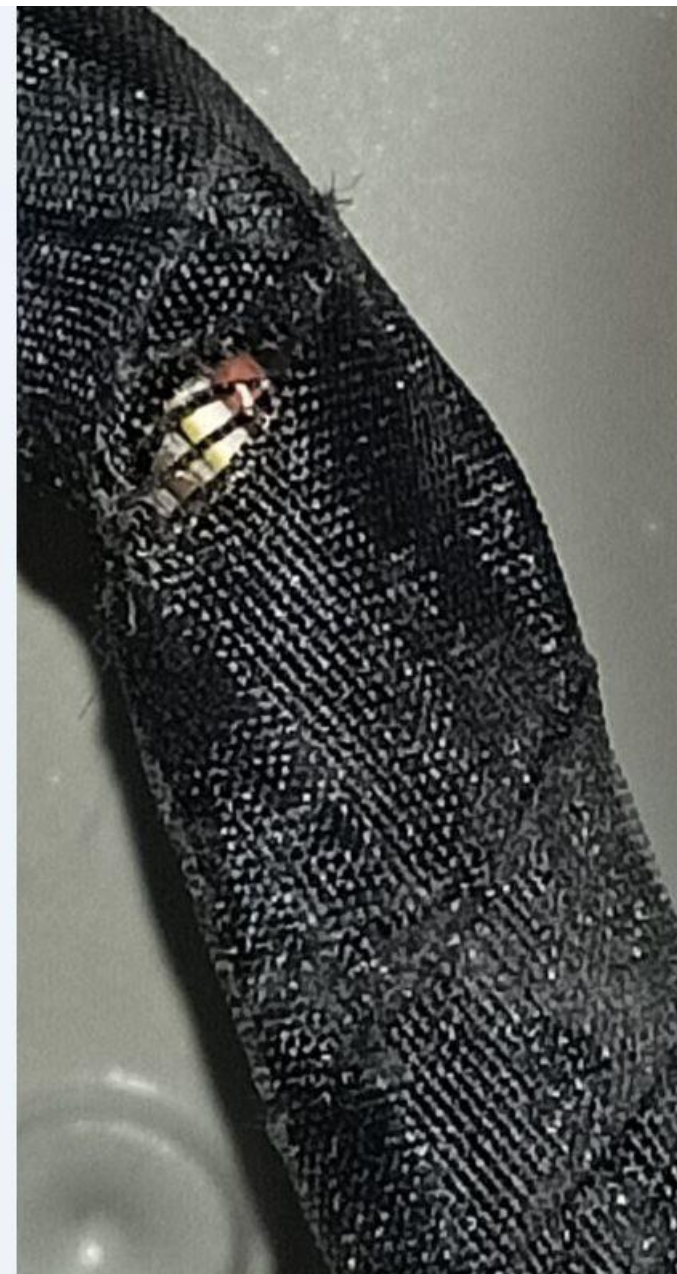
*TIP: Previous instances have highlighted the following after inspection:*

- Broken wires
- Kinked wiring
- Pin/s missing
- Pin/s broken
- Pin/s loose

NOTE: Refer to the example shown in Figure 1 of a damaged wiring harness

2) Repair any broken or damaged wires as per Rep.Gr 97
