# Technical Service Bulletin

PSS 93 Electrical Malfunction Message Displayed on Start up, DTCs P060600 and P0A1B00 Stored in Electric drive 2  
93 22 84 2068370/1 November 7, 2022.

| Model(s) | Year | VIN Range | Vehicle Specific Equipment |
|---|---|---|---|
| Q4 e-tron quattro, and Q4 Sportback e-tron quattro | 2022 | All | Not Applicable |

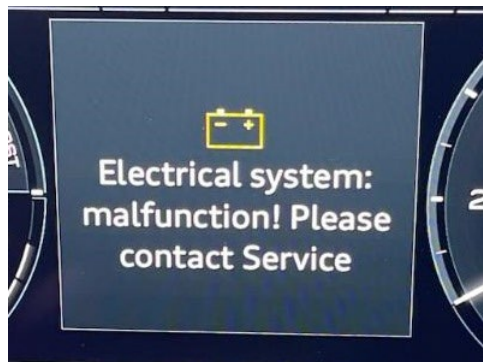
- Intermittently at start-up driver receives a malfunction message in the instrument cluster "Electrical system malfunction! Please contact Service" (Figure 1).
- After a key cycle the vehicle operates normally.

*Figure 1. A malfunction message is shown in the instrument cluster.*

The following DTCs are stored Electric drive 2 (DMC2), J944 (address word 00CE):

- DTC P060600: ECM/PCM Processor.
- DTC P0A1B00: Drive Motor "A" Control Module.

Software communication timing error on start-up.

- The warning is displayed on vehicle start-up.
- After an ignition cycle the vehicle operates normally.
- Clear the DTCs with the scan tool and confirm the vehicle drives normally on a test drive.

If the DTCs can be cleared and the vehicle drives normally the vehicle can be released to the customer.

Do not replace any parts as it will not fix the concern.

Explain to the customer if the concern happens again they should turn the ignition off, wait a couple of seconds, and then turn the ignition back on. The vehicle will then operate normally.
