## Technical product information

| <b>Topic</b> | DTC's P014800 and/or P008A00 - Rough running & potentially poor start up performance - MIL light on - Possible misfires |
| <b>Brand</b> | Bentley |
| <b>Transaction No.</b> | 2062016/4 |

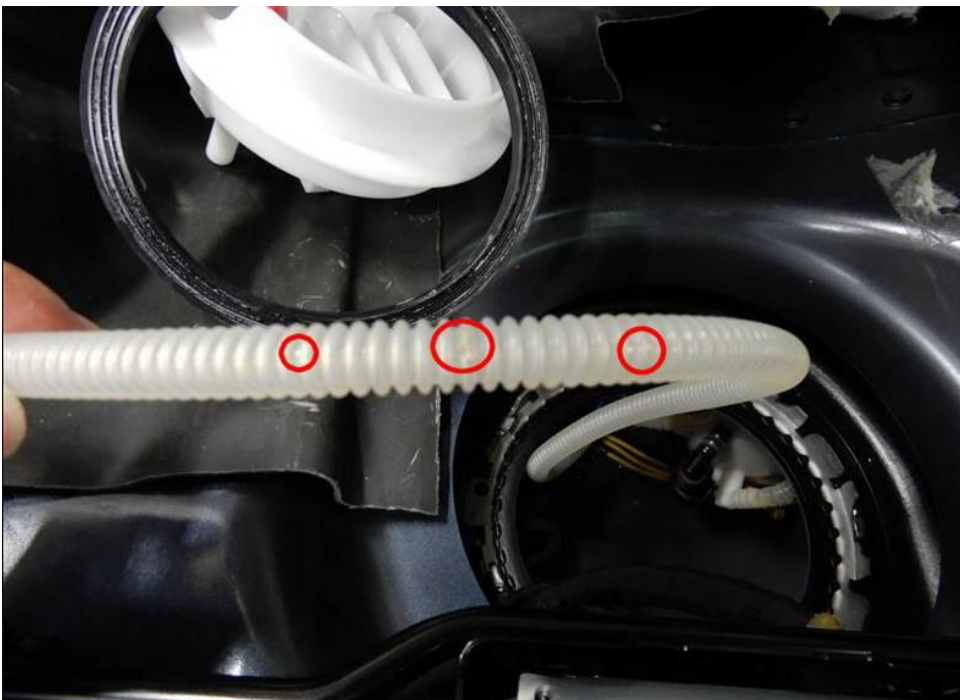
- Inspect the Fuel supply module and fuel filter fitment for detached hoses, damaged hoses and line and/or concerns with the module itself such as damage or leakage
- Figure 1 shows an example of a fuel tank internal hose with pin holes (circled)

9. Should any of the afore mentioned issues be evident the required parts should be replace as necessary  
 However in the event that all previous checks were to specification the operative should conduct step 10 to completion  
 10. Replace both bank 1 and 2 low pressure fuel rails, the fuel rails come complete with injectors (Figure 3).

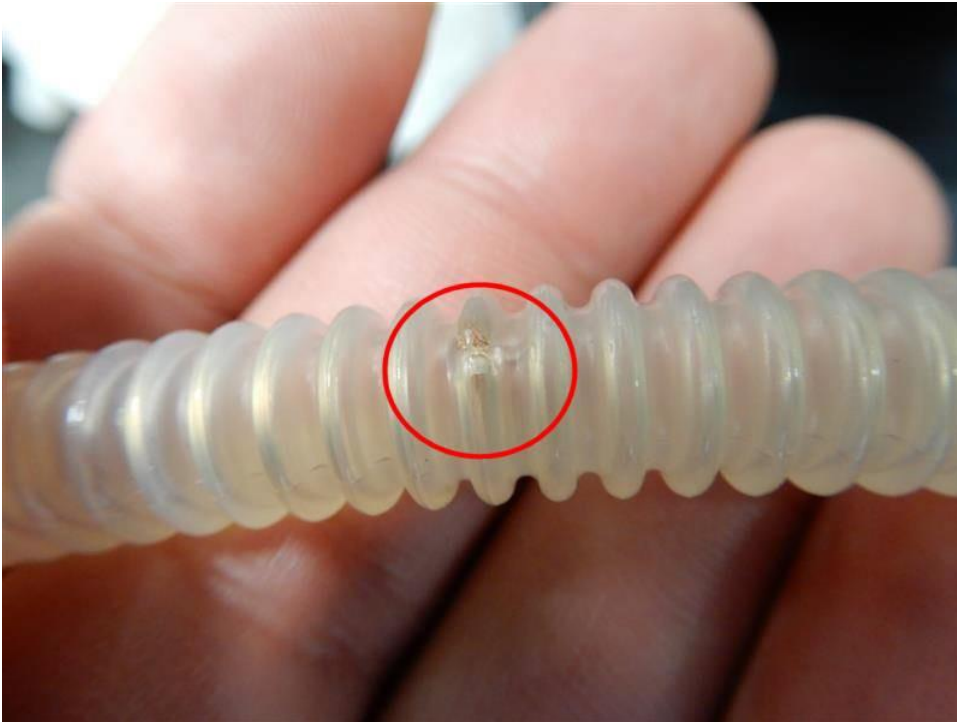
- Figure 2 shows a close up of the pin holes
