## Technical product information

| <b>Topic</b> | Engine coolant - Overheat condition - Warning evident within the DIP - DTC's P2B6500 and P2B8600 are evident |
| <b>Brand</b> | Bentley |
| <b>Transaction No.</b> | 2066669/2 |

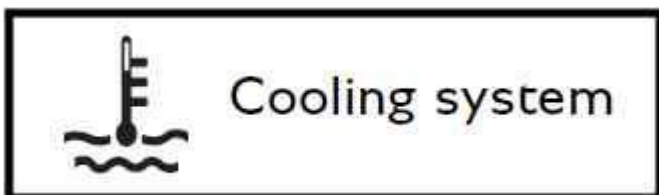
- Warning light in Drivers Information Panel (DIP) as Figure 1

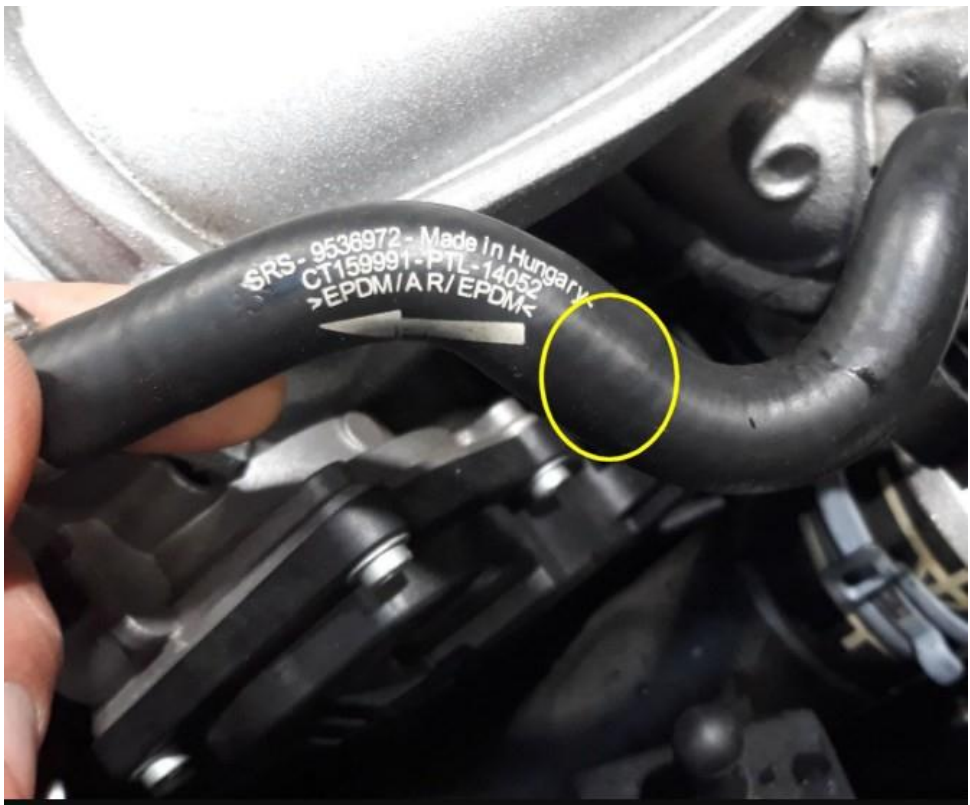
- The vent hose has an internal check valve, the valve is positioned within the vent hose at the location shown in Figure 3 (Circled)

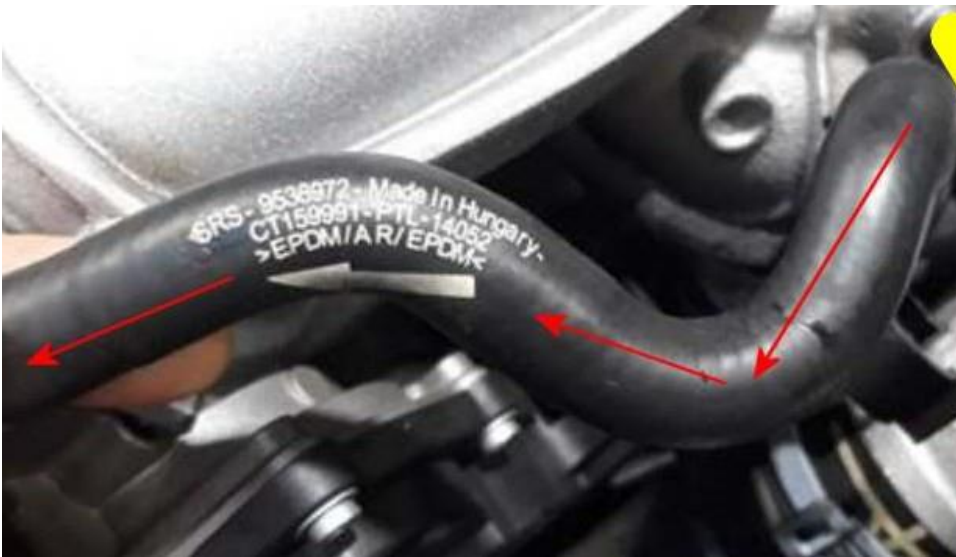
- Referring to Figure 4 - The coolant flows in the direction shown (Arrows) in the event the internal check valve is faulty the flow of the coolant will be restricted (Causing the symptoms described within the customer findings/workshop findings section)

4) Replace the vent line

- Once the vent line has been replaced - Referring to Rep.Gr 19 - Bleed the coolant system
- Erase all applicable DTC's
- Conduct a road test - On return check to confirm that no coolant related DTC's are evident

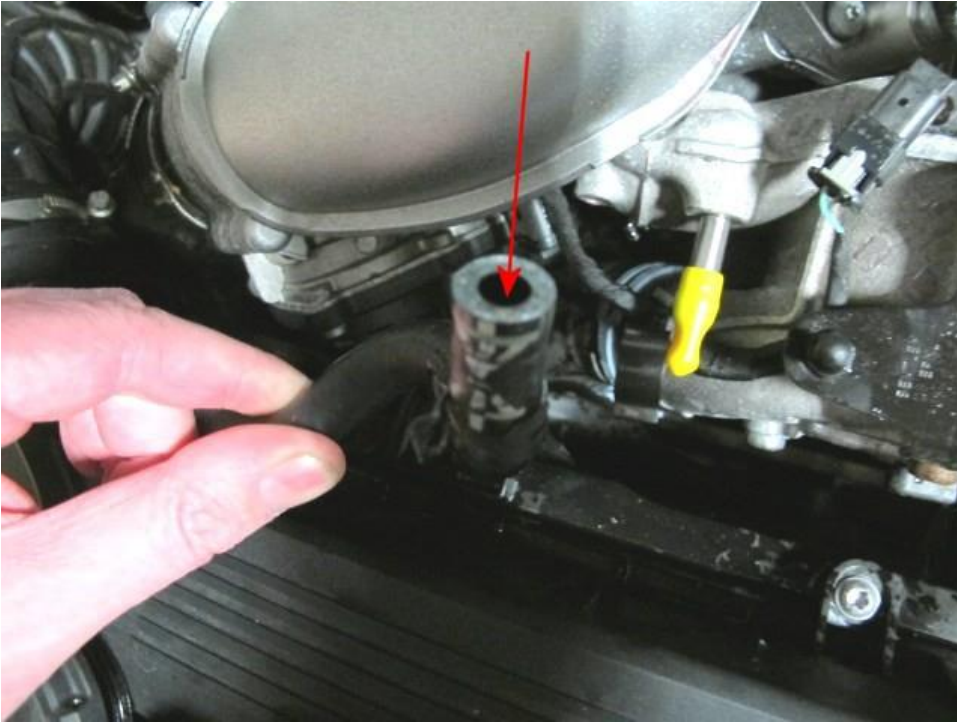
Does the air flow through the vent line without any restrictions? No

5) Referring to Figure 8 - Apply light air pressure into hose (Arrow)
