## Advanced Technical Information

**Bulletin #: 2104.5**

### Y1A Taycan

### On Board Charger (OBC) Fault P31D200 "Charging Socket – Overtemperature"

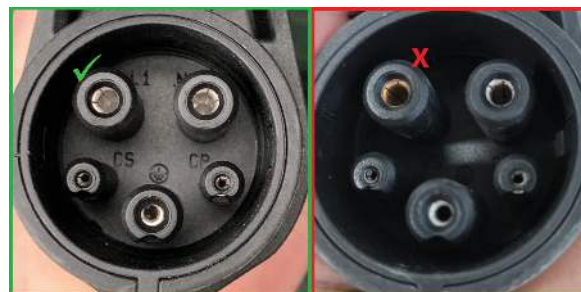
Figure 3

Visually inspect the pins in the vehicle cable connector for signs of overheating, paying particular attention to the L1 Pin. A vehicle cable and L1 Pin which was significantly or repeatedly overheated will show signs of discoloration (refer to Figure 3).
