## Technical product information

| <b>Topic</b> | DTC B17B801 and/or B17B804 - evident within address 0019 and/or DTC U112300 evident in 00A5 |
| <b>Brand</b> | Bentley |
| <b>Transaction No.</b> | 2063855/5 |

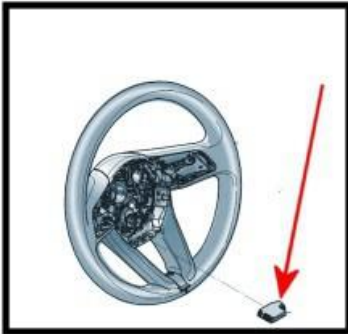
DTC - B17B801 - Steering Wheel Touch Recognition Control Module evident within address 0019

DTC B17B804 - Steering Wheel Touch Recognition Control Module electrical error - evident within address 0019

2) Referring to Figure 1 - Fit a new Control Unit for Steering Wheel Contact Detection (J1158) to the new steering wheel
