## Technical product information

| <b>Topic</b> | Coolant leaking from the mechanical coolant pump - Low coolant level warning - Engine overheating - DTC's evident |
| <b>Transaction No.</b> | 2065919/5 |

### W12 Bentayga - New Continental GT/GTC - New Flying Spur

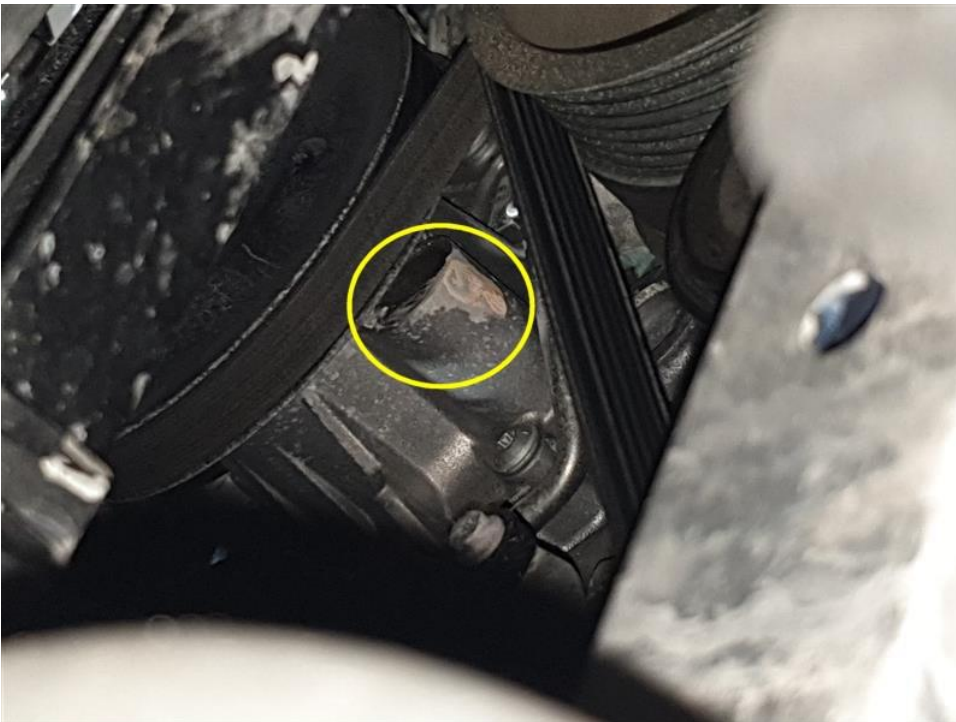
Figure 2

Refer to the video located within the Bentley Hub reference TPI 2065919/- this video shows an example of a coolant pump with no leak although there is a small coolant witness mark evident (Figure 2) in this scenario the coolant witness mark should be cleaned off (using a suitable cleaning agent) to the condition shown in Figure 3

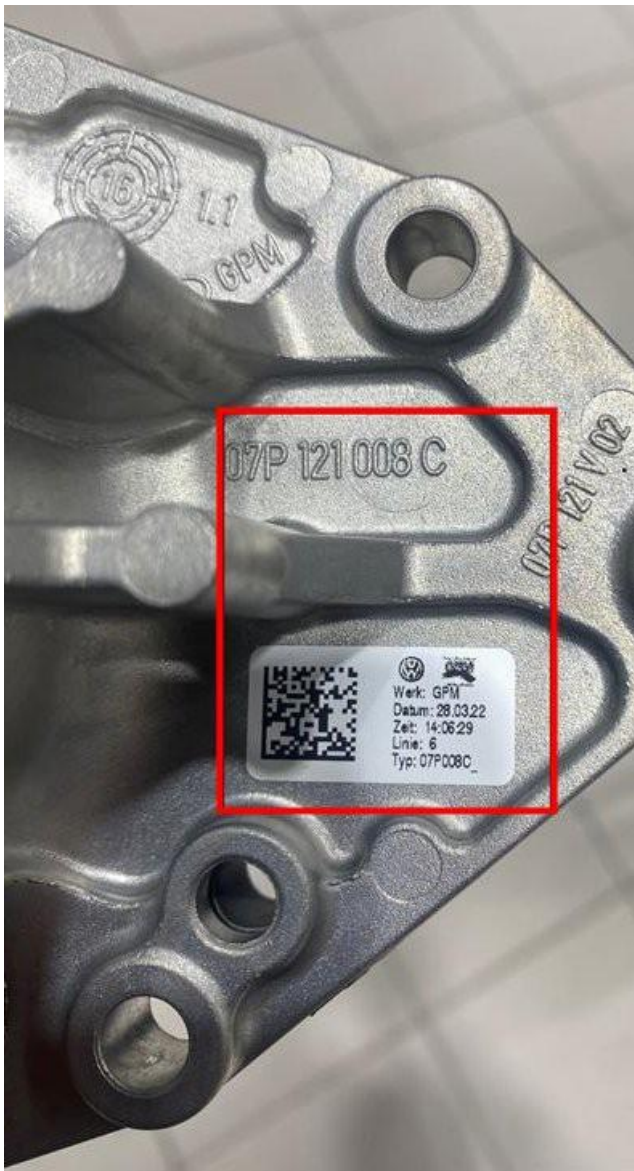
- Use a Mityvac or similar vacuum tool to check and confirm there are no vacuum related issues/leaks present within the system to check and confirm if N492 is sticking open and supplying a constant vacuum
- The operative must raise a technical DISS query or respond via an already open DISS query to request permission to replace the mechanical coolant pump ensuring the following is attached to the DISS query:
- Clear photo of the coolant level
- Clear photo of the original mechanical coolant pump part number 07P 121 008C (Figure 4)
- Video of the coolant leak whilst carrying out the pressure test
- Current ODIS log

*NOTE: The photo shown in Figure 4 is a C level coolant pump (shown removed from the vehicle for photographic purposes) a borescope may have to be used for photos of the coolant pump when fitted*

- Once permission has been given via the technical DISS query, replace the following
- Mechanical coolant pump - Rep.Gr 19
- Solenoid for coolant circuit N492 assembly - Rep.Gr 19
