# Technical Service Bulletin

## PSS 93 Electrical Malfunction Message Displayed on Start up, DTCs P060600 and P0A1B00 Stored in Electric drive 2

93 22 93 2068370/2 December 16, 2022. Supersedes Technical Service Bulletin Group 93 number 22-84 dated November 7, 2022, for reasons listed below.

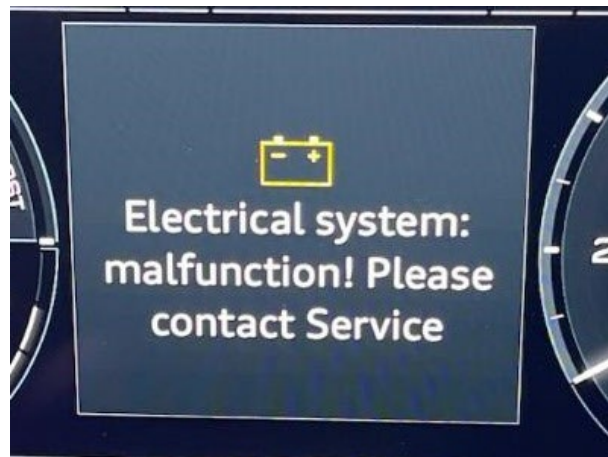
- Intermittently at start-up driver receives a malfunction message in the instrument cluster “Electrical system malfunction! Please contact Service” (Figure 1).
- After a key cycle the vehicle operates normally.

**Figure 1.** A malfunction message is shown in the instrument cluster.

Software communication timing error on start-up.

- The warning is displayed on vehicle start-up.
- After an ignition cycle the vehicle operates normally.
- Clear the DTCs with the scan tool and confirm the vehicle drives normally on a test drive.

Do not replace any parts as it will not fix the concern.
