# Technical Service Bulletin

| <b>Topic</b> | W12 Engine management light on - Turbocharger speed sensor DTC's stored |
| <b>Brand</b> | Bentley |
| <b>Transaction No.</b> | 2053348/10 |

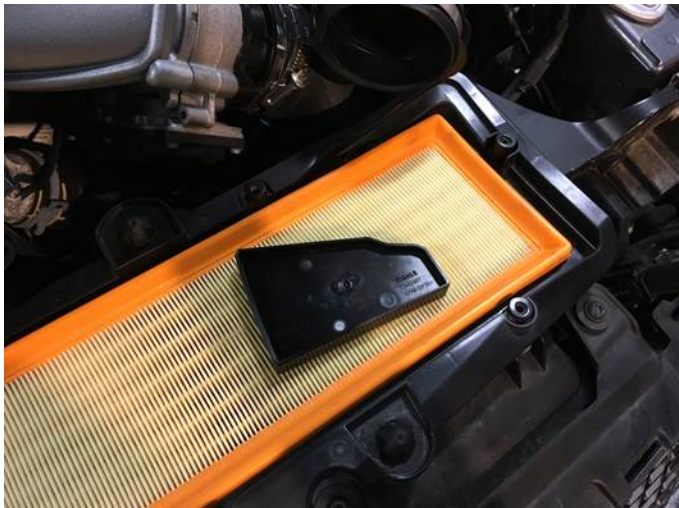
- Inspect for damage or missing components NOTE: The example in Figure 1 shows an air filter box divider that has become detached, causing DTC - P259400: Turbocharger Speed Sensor "B" - Circuit Range/Performance
- Reattach the divider and retest the vehicle if this particular fault is found

- Should no issues be found within the air filter box please continue with the remaining instructions from step 2
