## STAR ONLINE PUBLICATION

**Case Number:** S1908000159 REV. A

**Symptom/Vehicle Issue:** MIL Lamp On, DTC P0330 Knock Sensor 2 Circuit

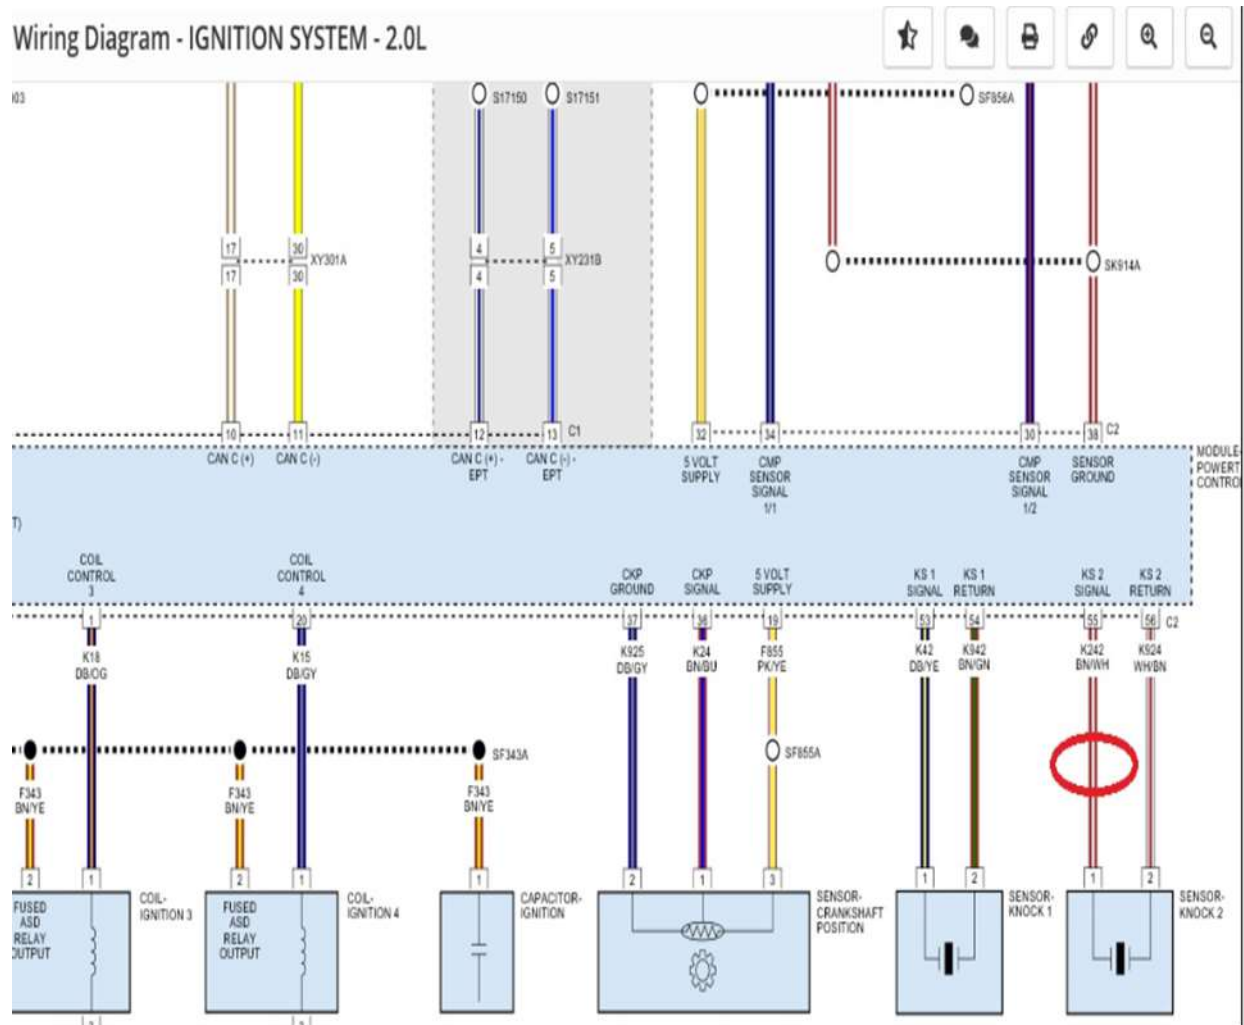
Fig 2 affected circuit in this case.

**Discussion:** Inspect the harness routing at the rear motor at the rear of the head / transmission bell housing location for any areas of pinching or contact. Inspect the harness routing for any contact areas between the transmission bellhousing and engine block. Repair any suspect harness damage and isolate the harness as needed from contact areas. No parts required Fig 1, 2.
