**NUMBER:** 08-049-22

UBE, UEE, UBU, UEU, UFE, UPE, UFU and UPU Radio Enhancements

This bulletin involves updating the radio with the latest available software.

2022 (MP) Jeep Compass

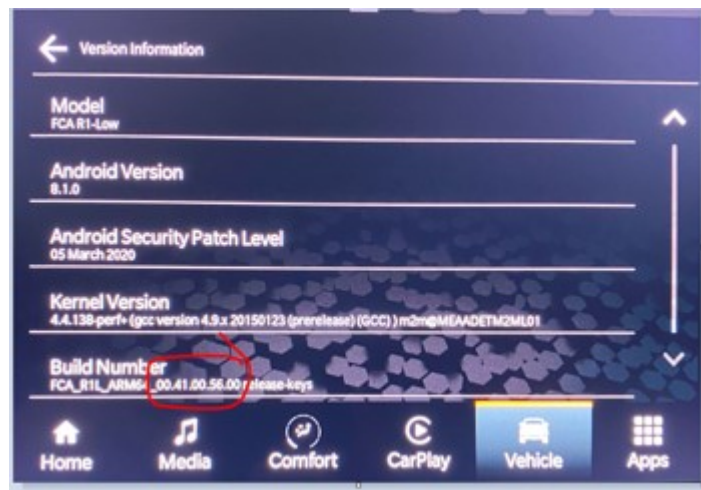
Fig. 1  
Software Version

- On the radio display screen go into "Vehicle Settings".
- Select "System Information".
- Select "Version Information".
- Under the "Build Number", radio software version is listed. For example, the software version here is 00.41.00.56.00 (Fig. 1) .

- YES>>> The software version is below R41.00.56. Proceed to [Step 1](#) of the repair procedure below.
- NO>>> If the software version is at or above R41.00.56, the radio is already at updated software. This bulletin has been completed.
