**NUMBER:** 08-068-22

Global Telematics Box Module (TBM2) Flash Over The Air Software Version Updates

2022 (MP) Jeep Compass

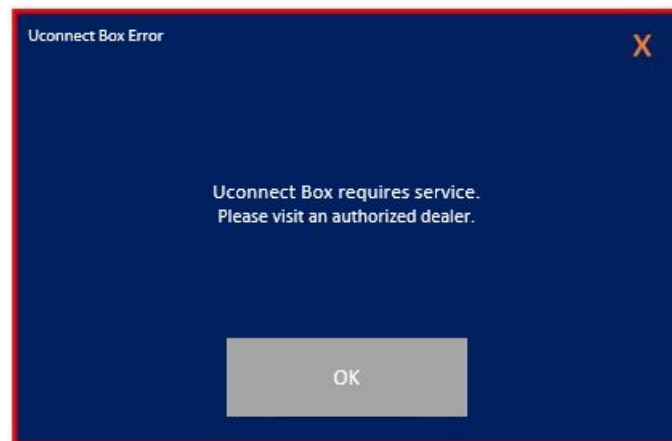
**Fig. 1**  
**Error Message**

- Message displayed on the radio screen, "Uconnect Box requires service. Please visit an authorized dealer." (Fig. 1) .

Upon further investigation, a technician may find the following DTC have been set:

- B1570-93 - USB Communication-No Operation.

This bulletin provides information regarding the latest Flash Over The Air (FOTA) update and provides the service technician an overview of the steps a customer will need to take to complete the update.

- Current Level 4.33J update to 4.34, launched on 03/25/2022.
