**NUMBER:** 18-061-22

Incorrectly Assembled Purge Flow Tube Inside Tube Elbow

2021 - 2022 (WL) Jeep Grand Cherokee

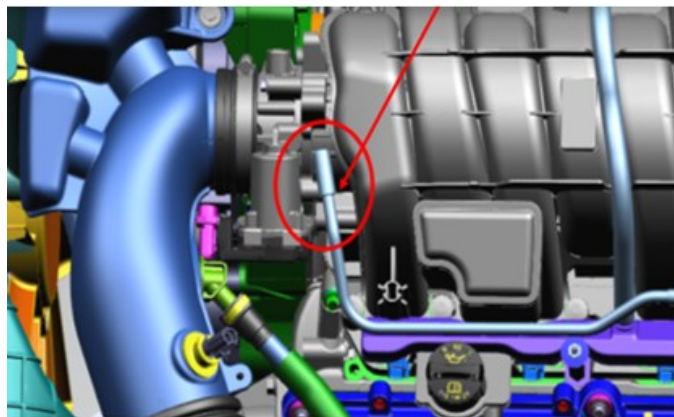
**Fig. 1**  
**Purge Hose at Intake Manifold**

1. Inspect the purge tube at the elbow on the intake manifold. ([Fig. 1](#))

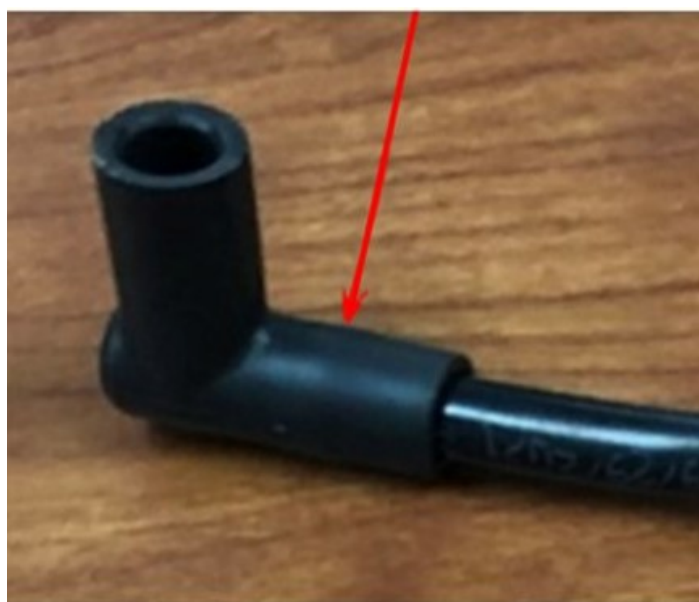
**Fig. 2**  
**Purge Tube Inserted Too Far**

1. Is the purge tube pushed too far into the elbow (Fig. 2) (Fig. 3) ?

2. Pull the nylon tube from the rubber elbow until the bead is positioned at the edge of the elbow. Ensure that the elbow is seated properly at the intake manifold port. (Fig. 4) , (Fig. 5)
