## STAR ONLINE PUBLICATION

**Case Number:** S2008000097

**Symptom/Vehicle Issue:** ESC Cluster Warning Lamp On, DTC B1783-01 Stop Lamp Control Circuit General Failure

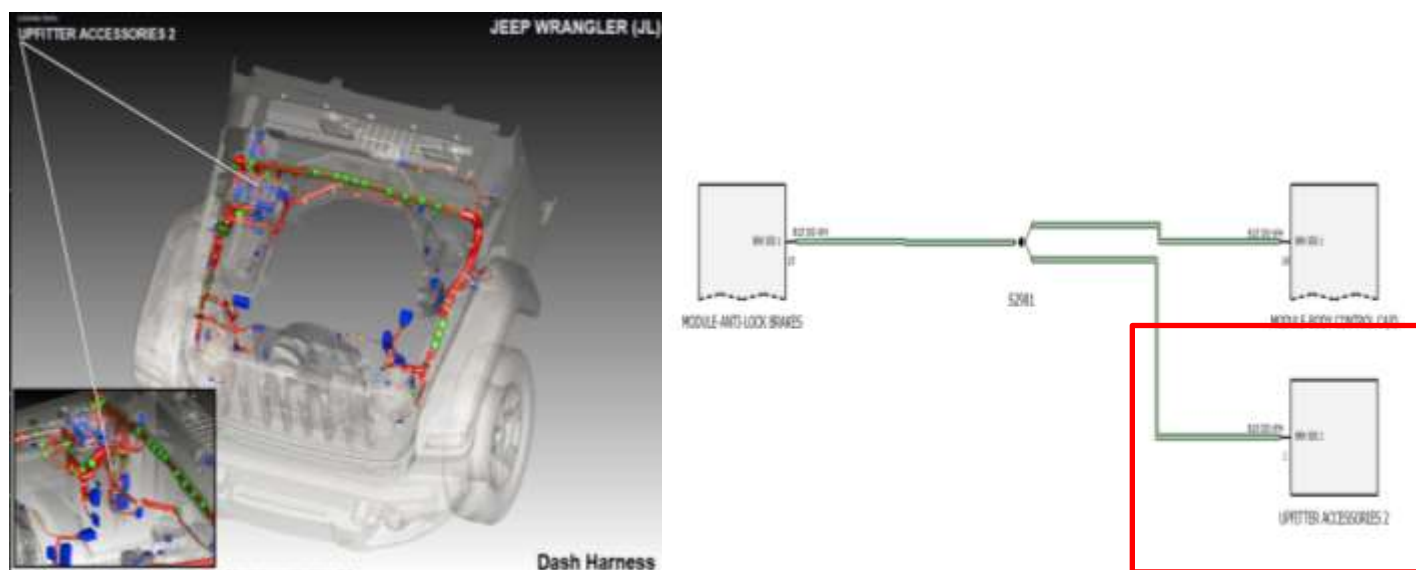
**Fig 1**

**Customer Complaint/Technician Observation:** Owner complains the ESC (Electronic Stability Control) warning lamp is on. Condition may have appeared after a recent service operation. Technician observed the lamp on with DTC B1783-01 Stop Lamp Control General Failure setting in the ABS module.

**Repair Procedure:** Inspect the up-fitter accessory 2 wiring take out for proper harness routing or signs of routing damage in the harness take out general location Fig 1, 2.
