## STAR ONLINE PUBLICATION

**Case Number:** S2008000186 REV. A

**Symptom/Vehicle Issue:** Engine Control Module (ECM) Flash Failure, Diagnostic Trouble Code (DTC) U1601 – ECU Application Software Code 1 Missing Or Corrupted

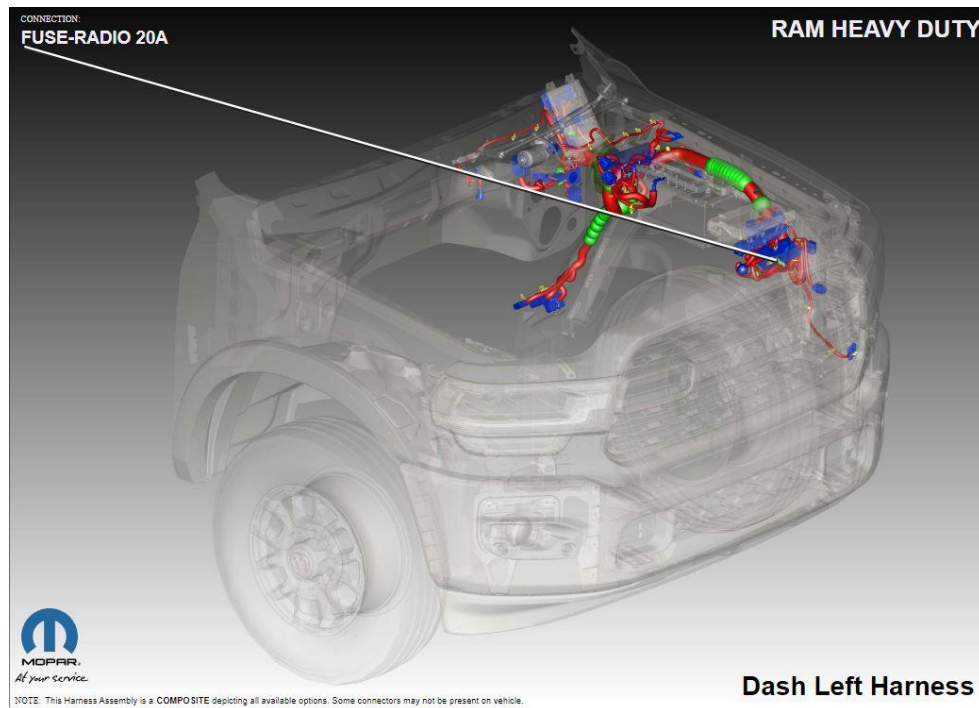
**Figure 1.**

**Discussion:** Several reports of ECM reprogramming failures have been received from the field. When the reprogramming process fails, it will often be accompanied by DTC U1601. Further investigation into these programming failures have found that most have been due to interference on the CAN C bus. This interference has been found to be caused by the following:

3. If no devices are found, or if everything is believed to be removed and the flash failure still occurs, disconnect the 20-amp Radio fuse located under the under-hood Power Distribution Center (PDC). Please see (Figure 1). This fuse supplies power to the radio and FTM/GTM if equipped.
