**NUMBER:** 18-101-22 REV. A

**GROUP:** 18 - Vehicle Performance

Flash: Powertrain Control Module (PCM) Updates

This bulletin involves reprogramming the Engine Control Module (ECM) / Powertrain Control Module (PCM) with the latest available software.

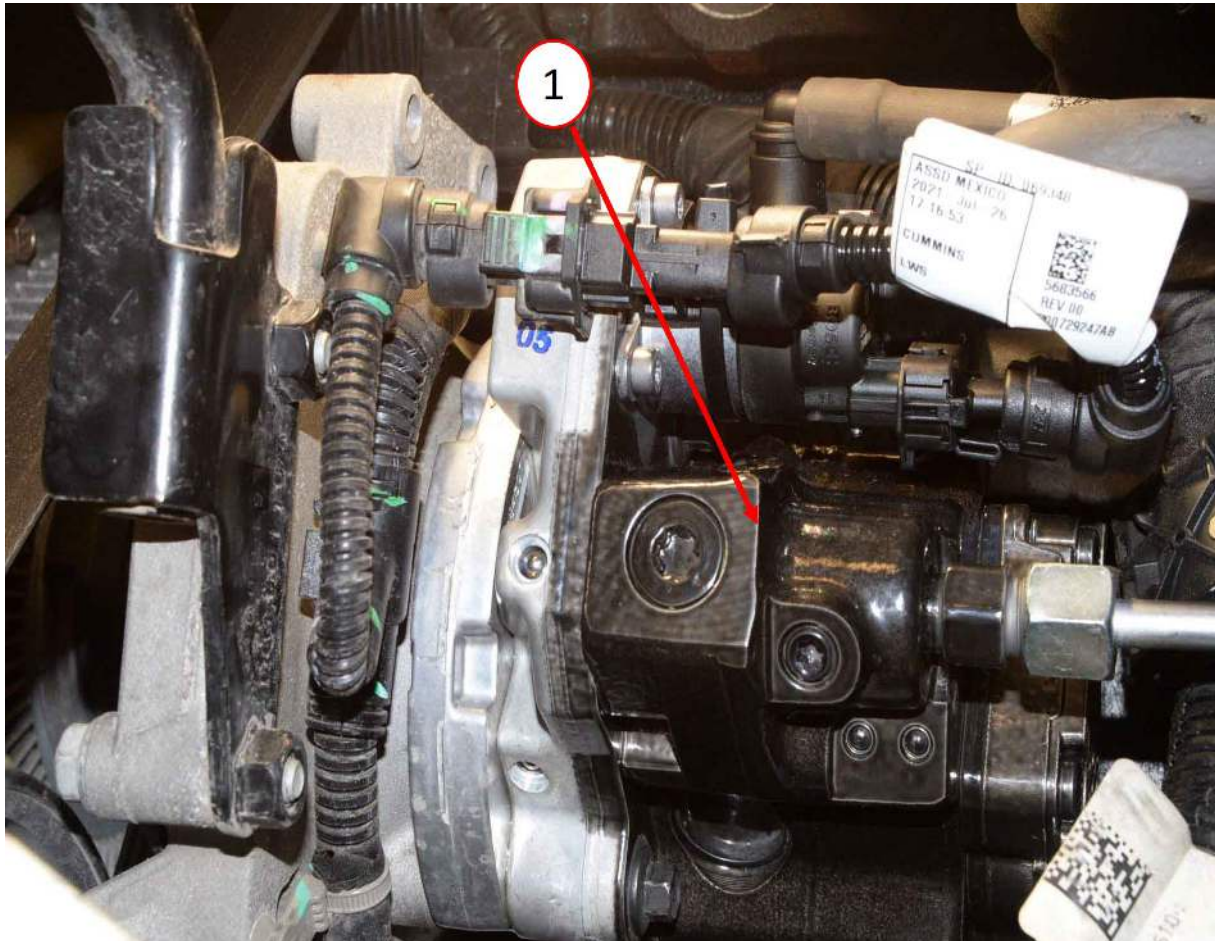
**Fig. 1**  
**CP3.3 Design Pump**

**NOTE:** The only calibration available will be for the updated CP3.3 design High-Pressure Fuel Injection Pump ([Fig. 1](#)) . Please ensure that recall Y78 has been completed first before proceeding with this update.

1. Inspect the High-Pressure Fuel Injection Pump to see which pump is currently installed on the vehicle ([Fig. 1](#)) . Also review the vehicle VIP report to see if campaign Y78 has been performed.

1 - CP3.3 Design Pump From Top View.

2. Does the VIP report indicate that Y78 has been performed, and is the vehicle equipped with the new design fuel injection pump released under the campaign?
  - YES>>> Proceed to [Step 1](#).
  - NO>>> Perform the Y78 campaign first. Once the campaign is performed, new pump installed and PCM updated, the PCM will have all of the updates listed in this document. This Bulletin does not apply.
