**NUMBER:** 18-102-22 REV. A

Flash: Powertrain Control Module (PCM) Updates

| 2020 | (DJ) | RAM 2500 Pickup |
| 2020 | (D2) | RAM 3500 Pickup |

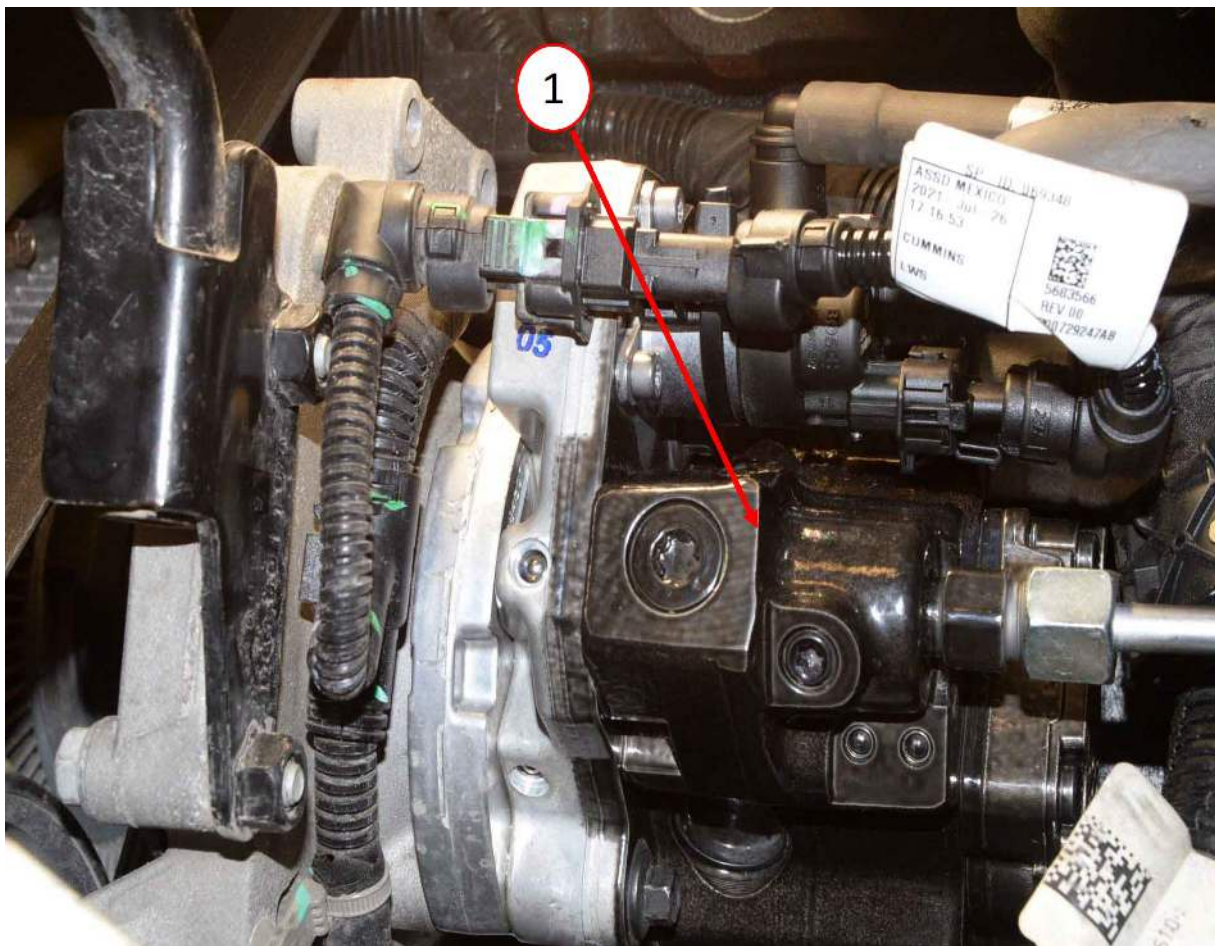
**Fig. 1**  
**CP3.3 Design Pump**

**NOTE:** The only calibration available will be for the updated CP3.3 design High-Pressure Fuel Injection Pump (**Fig. 1**) . Please ensure that recall Y78 has been completed first before proceeding with this update.

1. Inspect the High-Pressure Fuel Injection Pump to see which pump is currently installed on the vehicle (**Fig. 1**) . Also review the vehicle VIP report to see if campaign Y78 has been performed.

1 - CP3.3 Design Pump From Top View.

2. Does the VIP report indicate that Y78 has been performed, and is the vehicle equipped with the new design fuel injection pump released under the campaign?
  - YES>>> Proceed to [Step 1](#).
  - NO>>> Perform the Y78 campaign first. Once the campaign is performed, new pump installed and PCM updated, the PCM will have all of the updates listed in this document. This Bulletin does not apply.
