## STAR ONLINE PUBLICATION

**Case Number:** S2008000131 Rev. D

**Symptom/Vehicle Issue:** U11E9 Lost Communication with AGS (Active Grille Shutter), Malfunction Indicator Lamp (MIL) Illuminated

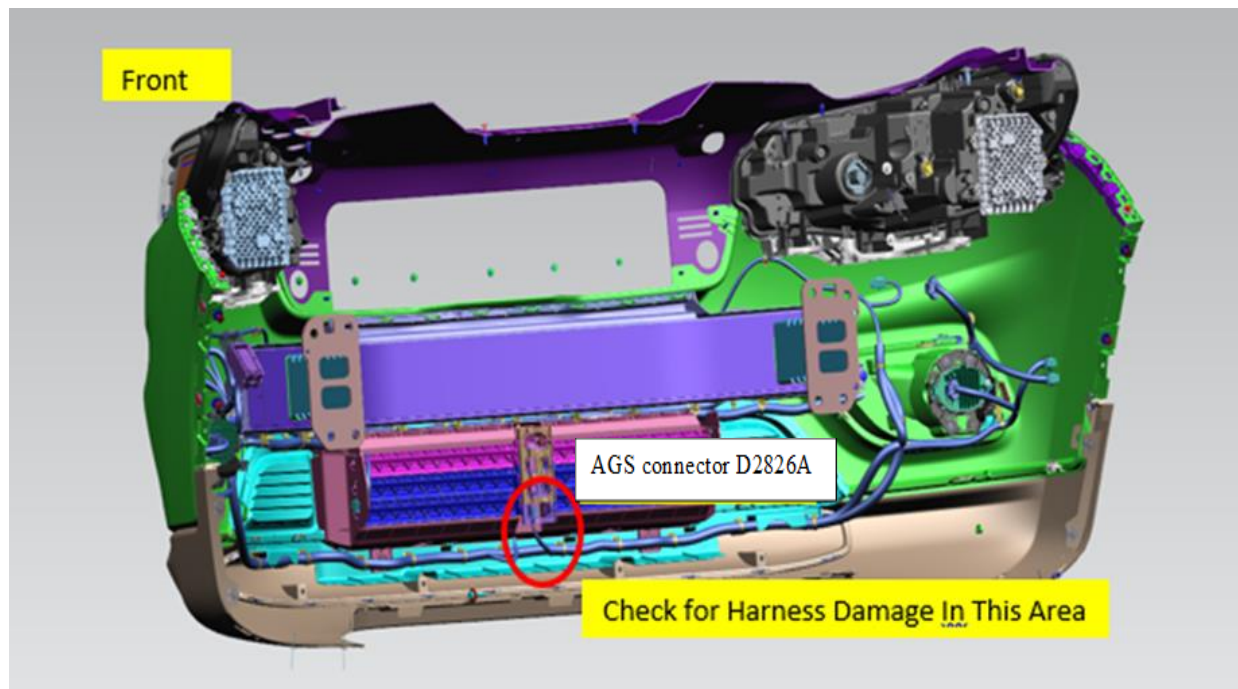
**Repair Procedure:** Inspect the below suspect connector and wiring harness locations for signs of damage. Inspect harness as needed at suspect locations looking for stretched or twisted circuit wires (example below). Disconnect and reconnect the AGS Connector (D2826A) to ensure it is properly seated if no signs of damage or corrosion.
