## STAR ONLINE PUBLICATION

**Case Number:** S2208000147

**Symptom/Vehicle Issue:** Vehicle Does Not Respond. wiTech Has Limited Or No Communication With The Vehicle. U0001-00 For CAN C Bus

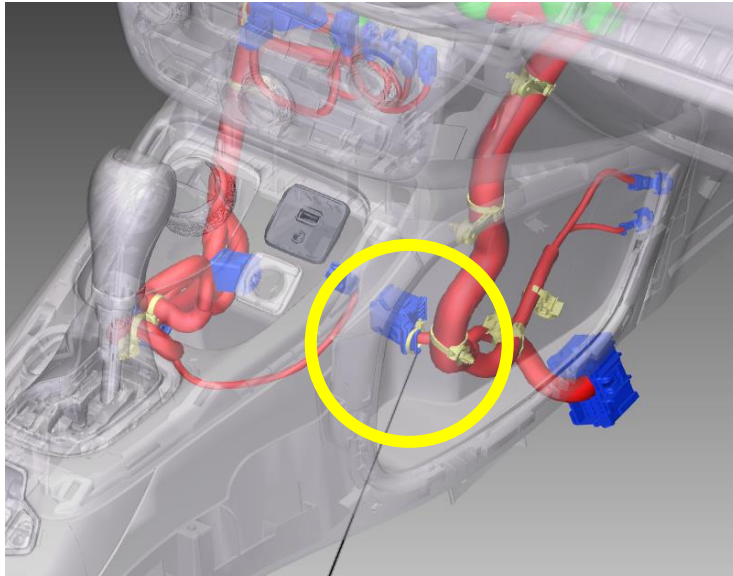
If a short to ground on CAN C +/- is found. The short may be caused by a bolt pinching/crushing the wiring harness under the floor console near the ORC. Remove the floor console and inspect the wiring harness.

**ORC Connector Under Floor Console**

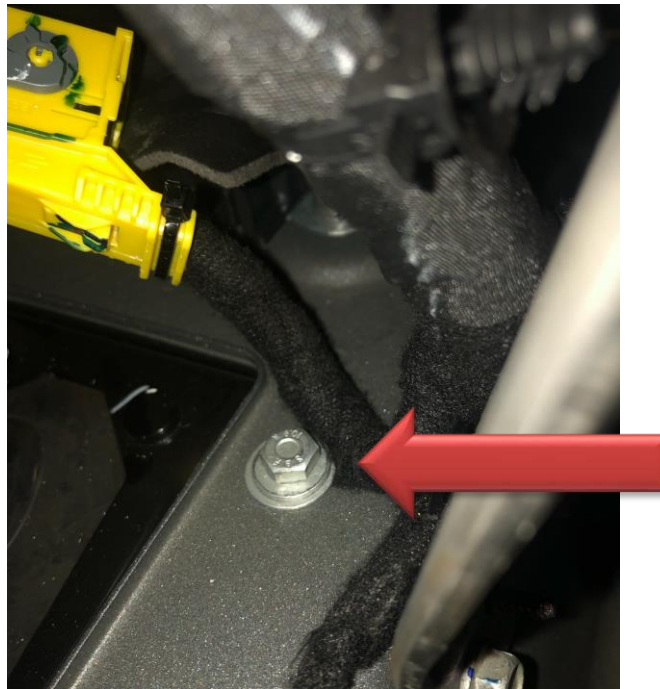
**Wiring Harness Crushed Under Bolt**

**Repair Procedure:** Repair any damaged circuits using standard wiring repair practices. If necessary, replace the wiring harness.
